Project No. CA0053161.3566

**BUILDING CONDITION ASSESSMENT**  
**ARCHIE BROWNING SPORTS CENTRE**  
**1151 ESQUIMALT ROAD**  
**Victoria, British Columbia**

DECEMBER 16, 2025

**WSP Canada Inc.**

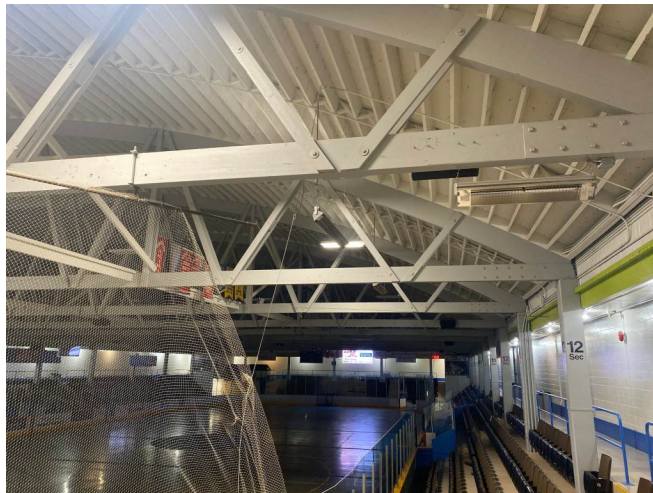
Photo #2: Arena Roof Structure

The exposed roof structure over the north hockey arena, including wood trusses, joists, and decking, appeared in serviceable condition with no signs of structural distress. Truss bearing connections at concrete columns or steel brackets also appeared stable. The roof structure over the curling rink could not be reviewed due to ceiling finishes; we recommend its inspection during future ceiling access opportunities.

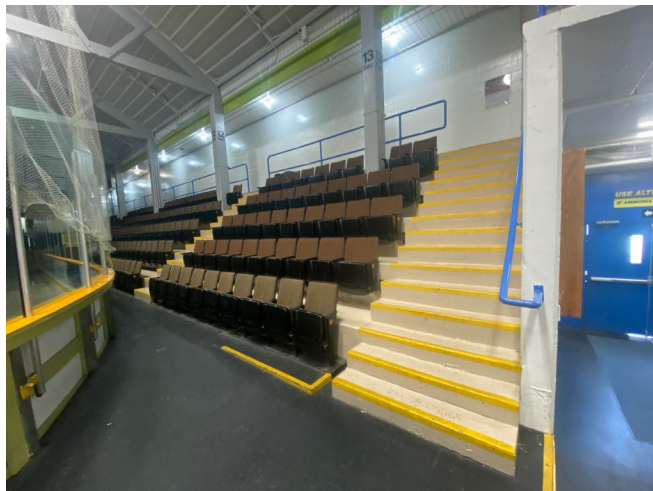
Photo #3: Bleacher Concrete Structure

Load-bearing CMU walls and cast-in-place concrete beams showed no signs of cracking or displacement. The concrete bleachers and seating structure were intact with only typical surface wear. Interior and exterior stair assemblies, including painted steel and concrete-framed stairs, were secure, with no major defects or corrosion observed.

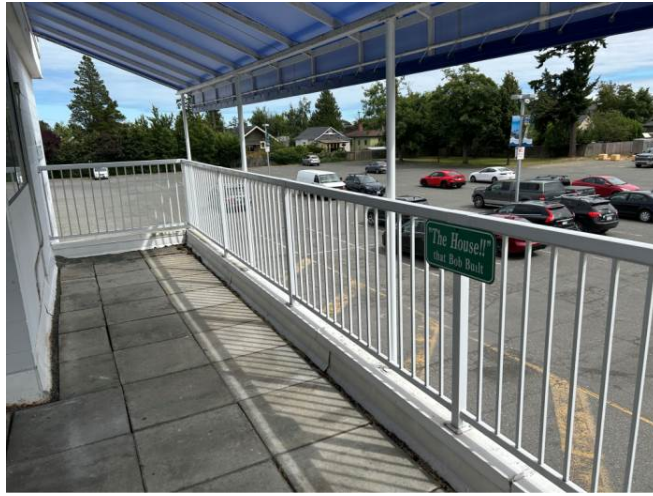
Photo #4: South Balcony

The south balcony assembly shows signs of aging and water exposure, including corrosion at flashing and door frames, worn pavers, and rusting canopy supports. A full replacement is recommended, including membrane, pavers, flashing, sliding door, guardrails, and canopy.

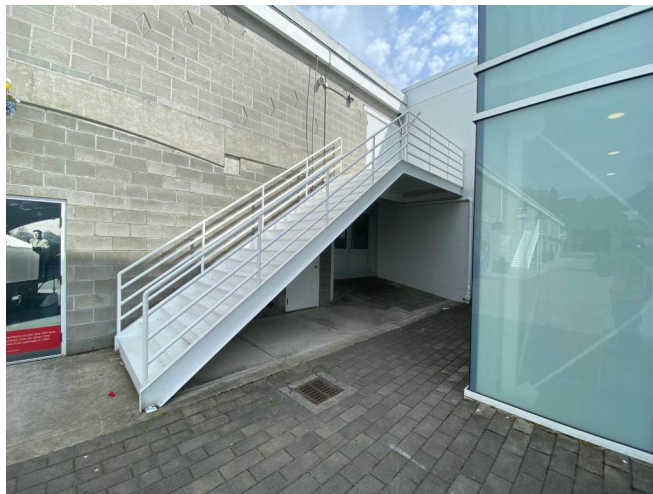
Photo #6: Exterior Metal Staircase

The exterior metal staircases appeared in good condition with no structural concerns noted. Regular inspection of fasteners, welds, and surface coatings is recommended to ensure continued performance. Repainting and other minor upkeep are assumed to be covered by ongoing maintenance budgets, with no capital cost allocated.

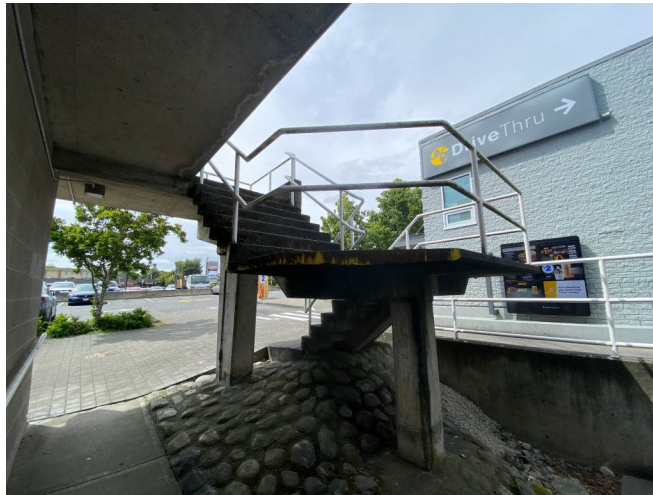
Photo #7: Exterior Concrete Stairase.

Localized concrete spalling with exposed reinforcement was noted at the northwest exterior concrete staircase. We recommend patch repair and protective recoating, which we assume can be completed at relatively minor cost below the capital threshold of this project as a maintenance item.

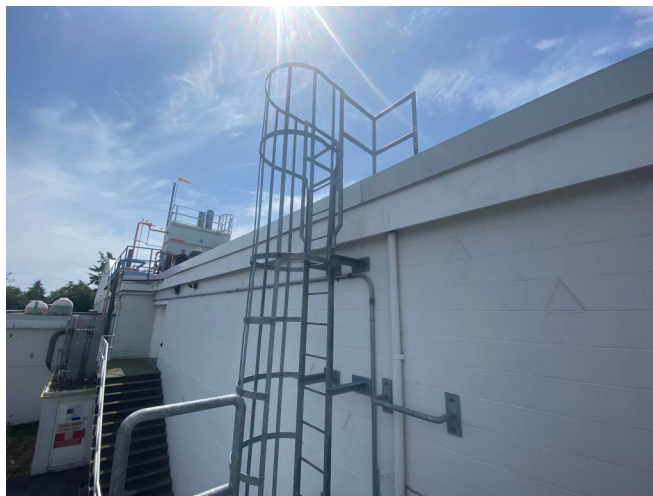
Photo #8: Caged Ladder

The caged ladder appeared in excellent condition with no signs of corrosion, damage, or instability. It appears to be relatively new, with no replacement anticipated during this reporting term. Regular inspection and maintenance are essential to ensure continued safe use.

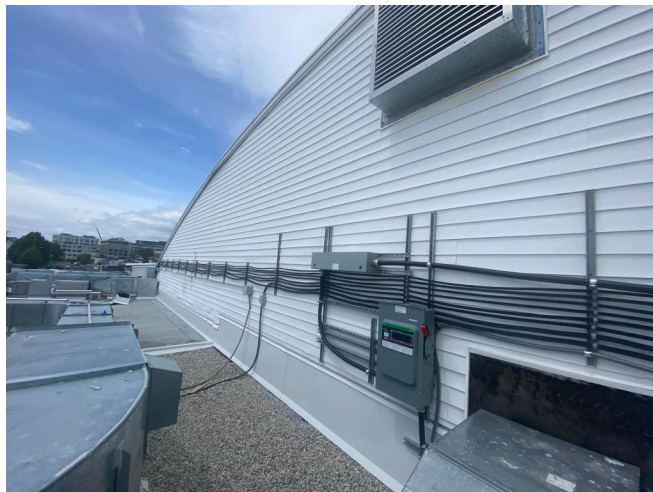
The exterior walls clad with profiled vinyl siding appear to be in serviceable condition.

Photo #9: Vinyl Clad Walls

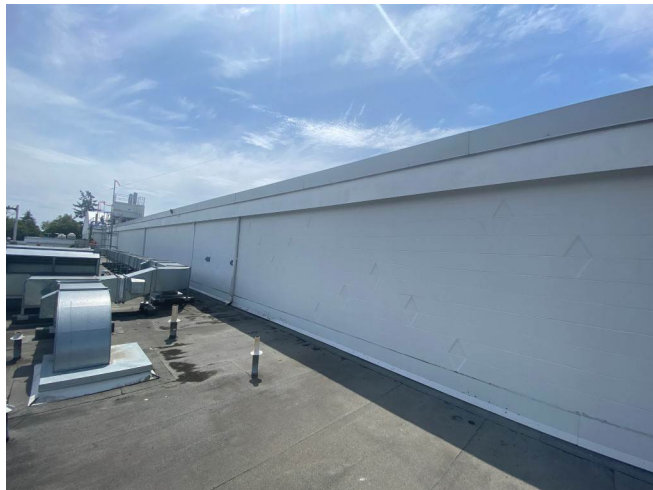
Photo #12: 2-Ply SBS Roofing in Fair Condition

Flat roofs are scheduled for phased replacement: the oldest sections around the Hockey Arena office areas in the short term due to end-of-life condition, the eastern sections in the medium term, and the newer western and central areas near year 2045.

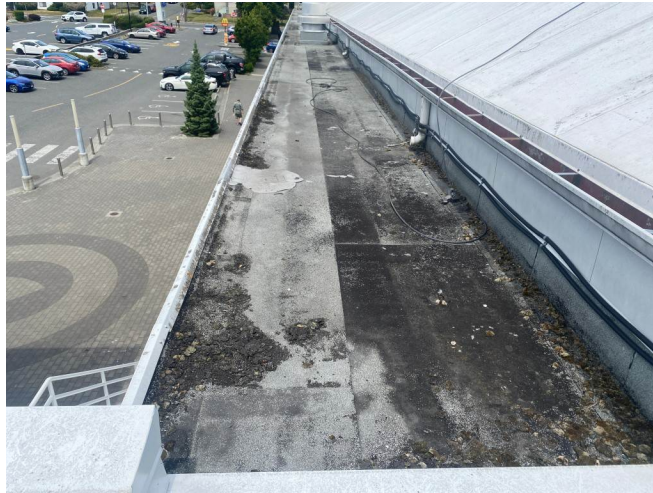
Photo #13: 2-Ply SBS Roofing in Poor Condition

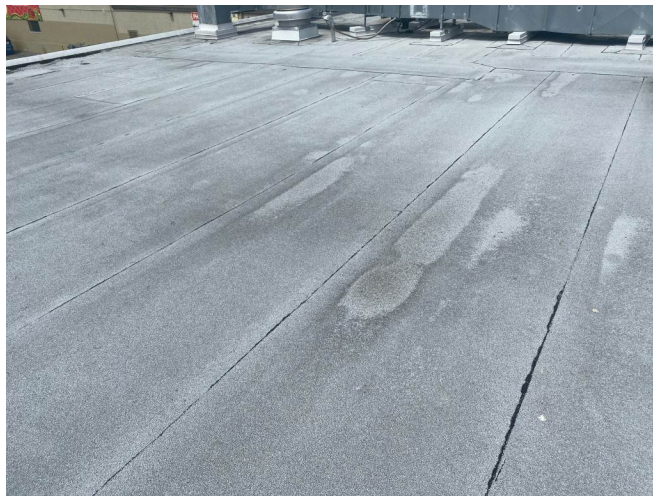
Photo #14: 2-Ply SBS Roofing in Serviceable Condition

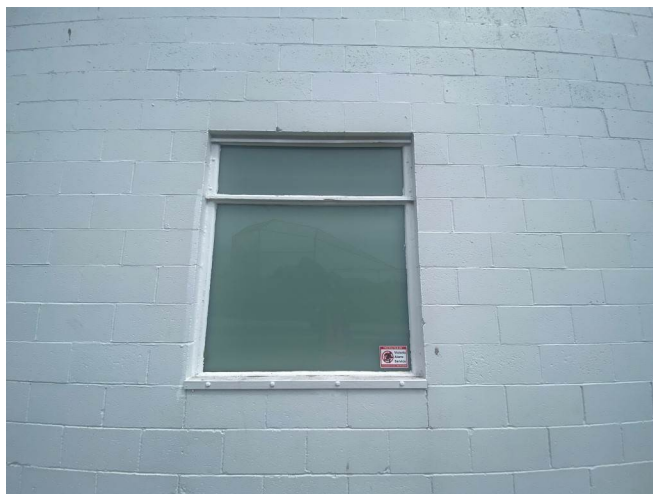
Photo #18: Older Windows

Windows vary in age and performance. Older metal units are inefficient and prone to leakage. Newer units perform better but lack consistency. Full window replacement with uniform, thermally broken frames and IGUs is recommended.

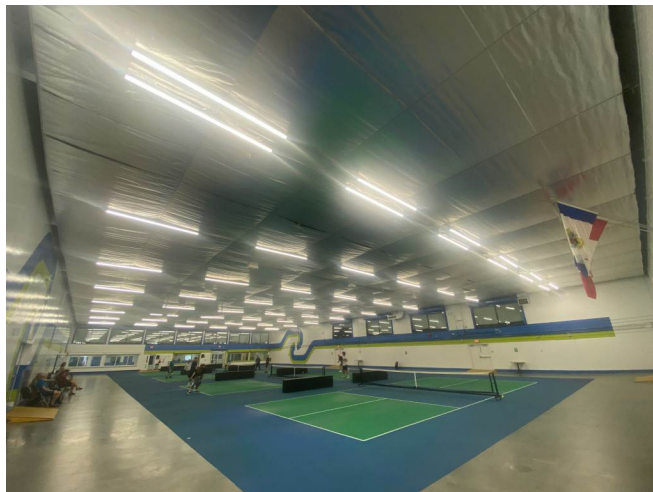
Photo #25: Drop Ceiling in Curling Arena

The Curling Arena fabric ceiling has localized damage and requires ongoing repairs until full replacement. Reinstating a similar but impact-resistant ceiling fabric in the Hockey Arena is recommended.

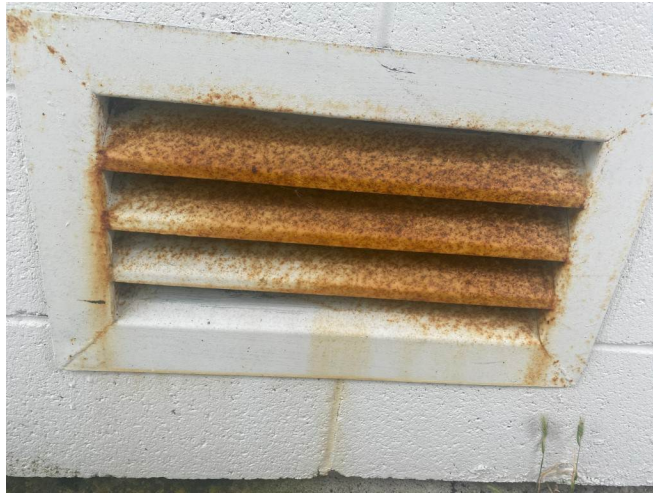
Photo #26: Ventilation Louvre in Poor Condition

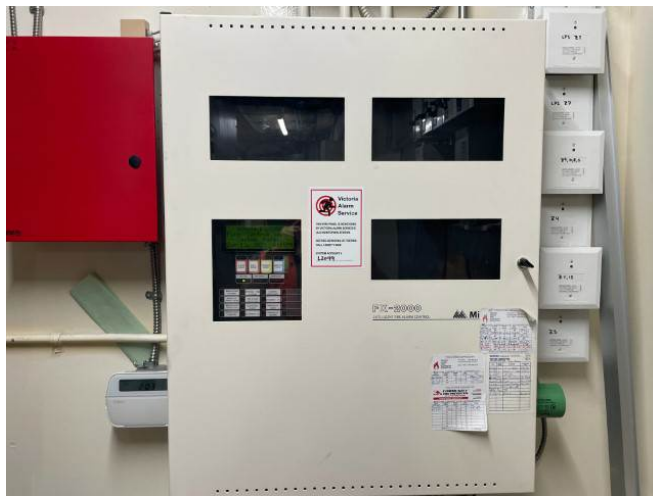
Photo #27: Fire Alarm Control Panel

The fire alarm panel is anticipated to reach the end of its typical service life within the next five years. Due to the life-safety nature of the equipment, we recommend proactive replacement at that time to mitigate potential unplanned failures and replacements.

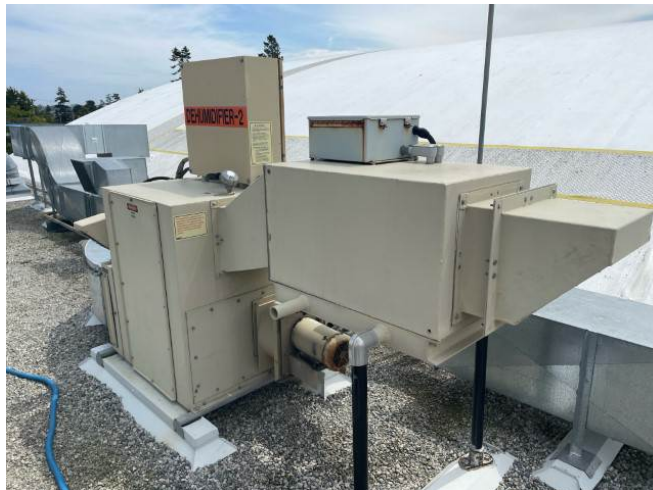
Photo #28: Curling Rink Dehumidifier Unit

The dehumidifier unit (DH-2) serving the curling rink is older and expected to require replacement in the next few years. The replacement unit is expected to be a packaged electric unit similar to DH-1 serving the hockey rink.

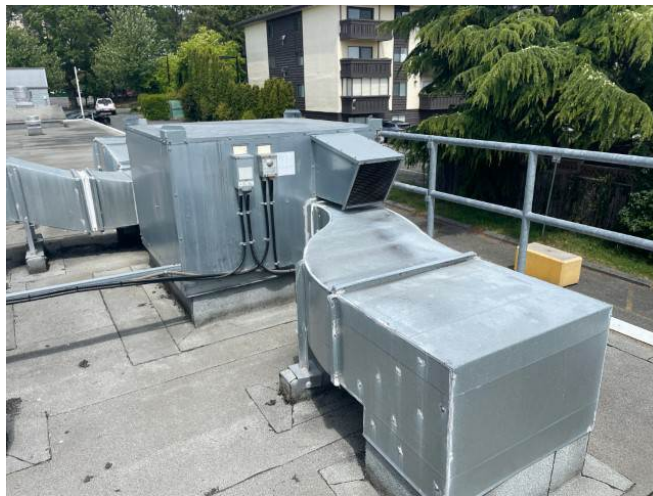
Photo #30: Rooftop HRV

The HRV was not functioning at the time of review, and the Maintenance Coordinator reported that it is no longer used. Based on the age and condition, replacing most of the supplemental HVAC equipment will be required within the report term, including the HRV and hockey rink heaters. As such, replacement projects have been included within the report term.

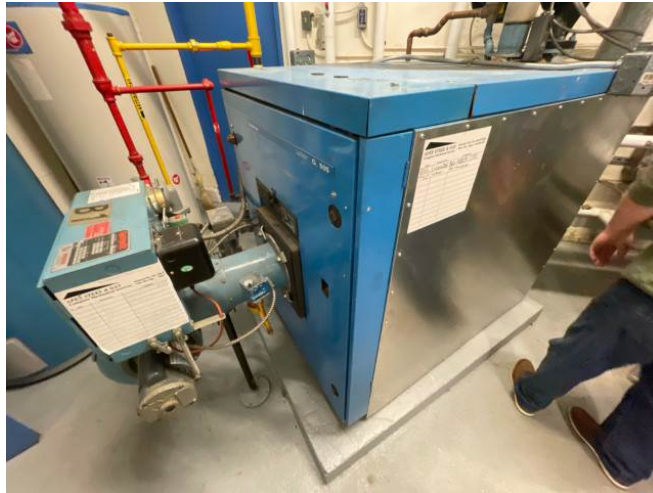
Photo #38: Gas-fired Boiler

While the two gas-fired boilers have had overhauls and upgrades over the years, they have exceeded their typical service life and general replacement is anticipated within the next few years. The Maintenance Coordinator reports that one of the water heater tanks failed last year and is scheduled for replacement this year. The other tank is reportedly of similar age, functional, but it has reached the end of its typical service life. As such, the report includes the replacement of both heater tanks in the short term.

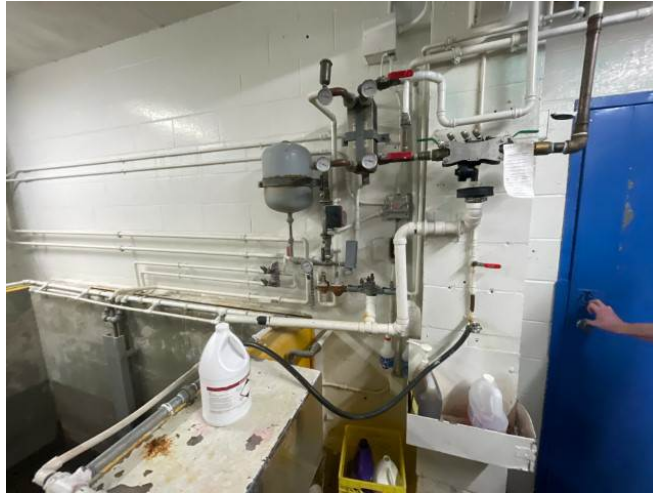
Photo #41: Ice Melt Pit

The Maintenance Coordinator reported that the ice melting pit heat rejection loop is not currently operational, and there are plans to repair and replace components to have it running again. As such, the report includes the replacement of the ice melt pit boiler, circulation pump, heat exchanger, and expansion tank.

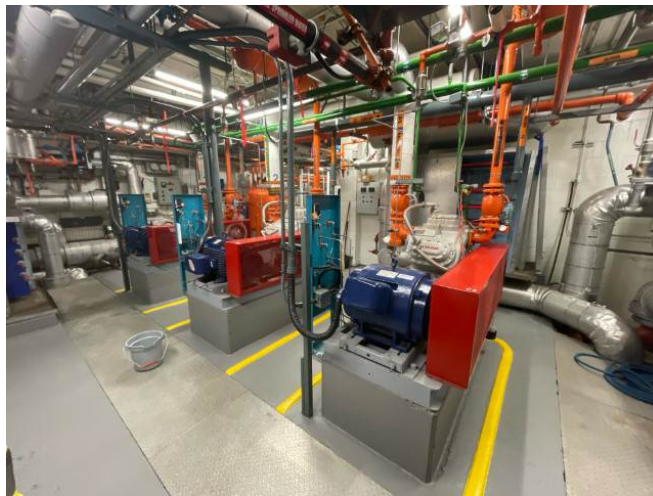
Photo #42: Ice Plant Compressors

The four ice plant compressors vary in age and have all undergone overhauls over the years. Given the age of the components, overhauls of each of the compressors are anticipated within the report term, assuming replacement parts can continue to be sourced.

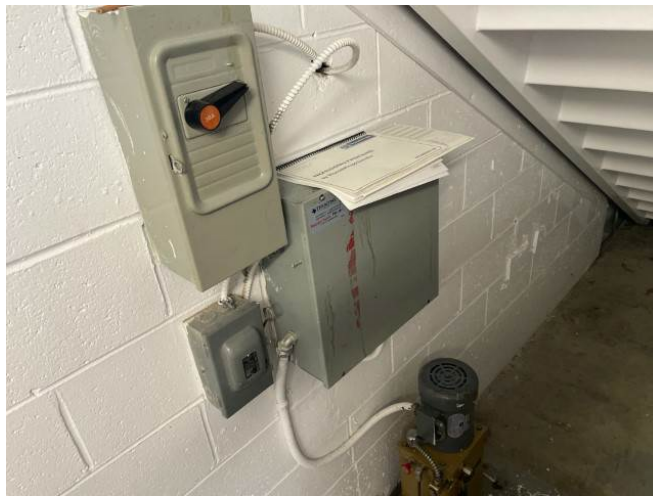
Photo #54: Elevator Machine

The age of the hydraulic pedestrian lift components is unknown, but they are estimated to be between 30 and 50 years old. The lift was likely installed at a time before internal safety bulkheads or modern corrosion protection measures were mandatory. Based on the age of the system, we recommend planning to replace the cylinder and modernize the controls within the report term.
