Project No. CA0053161.3566

**BUILDING CONDITION ASSESSMENT**  
**ESQUIMALT RECREATION CENTRE**  
**527 FRASER STREET**  
**Victoria, British Columbia**

DECEMBER 16, 2025

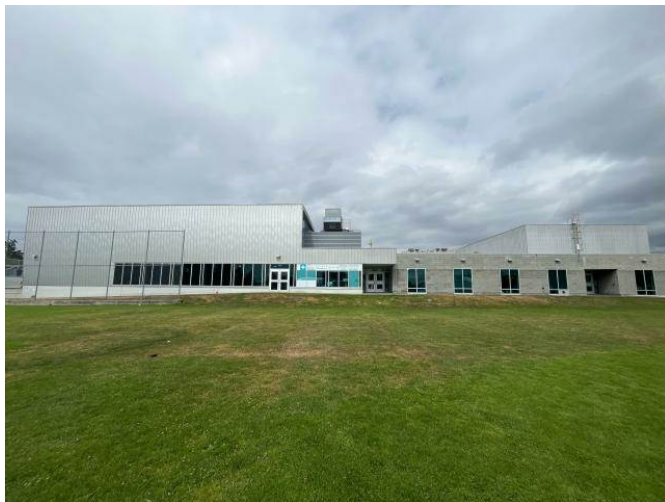
Photo #2: East Elevation

The window and door perimeter sealant were generally intact, flexible, and functioning as intended. However, localized failures, such as splitting, were noted along portions of the east elevation. As the building continues to age, the perimeter window and door sealants are more susceptible to failure. We expect these sealants will continue to be monitored and locally repaired at a cost below the capital threshold, until a larger re-painting project occurs. At the time of re-painting the metal cladding, we recommend also replacing the window and door perimeter sealants.

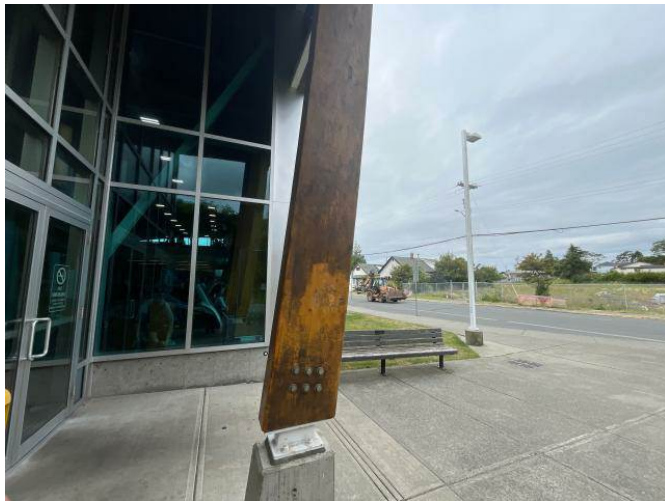
Photo #6: Entrance Glulam Columns

Observed signs of deterioration of the glulam columns at the main entrance include staining of the wood and corrosion of the steel baseplates and associated hardware. To mitigate further deterioration, we recommend periodic recoating of both the timber and baseplates as part of routine maintenance.

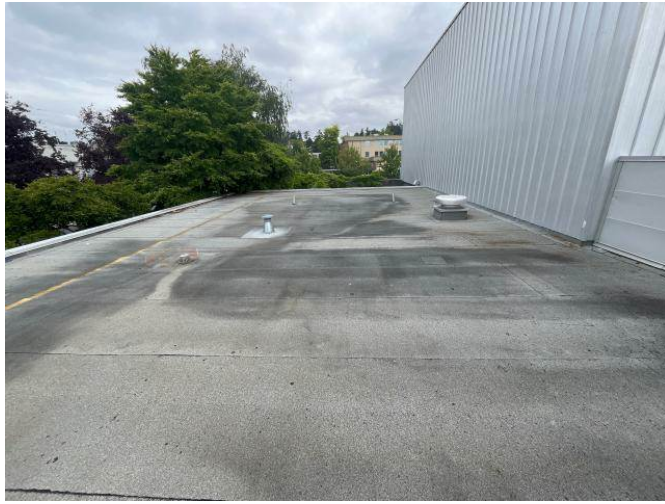
Photo #7: Flat Roofing - General Condition

We understand a Roof Asset Management Plan (RAMP) was completed by Garland Canada Inc. dated May 7, 2024. The findings outlined in the RAMP report generally align with the roofs conditions observed during our site review. We observed areas of degranulation, local blistering, evidence of previous water ponding and patch repairs, alligator cracking, failed penetration sealants, blocked area drains, and accumulated debris.

All roof sections were originally installed in either 2000 or 2004, making them about 20 to 25 years old. As such, they are approaching the end of their expected service life. Given the visible membrane deterioration and past history of localized leaks, replacement budgets have been included within the term of this report.

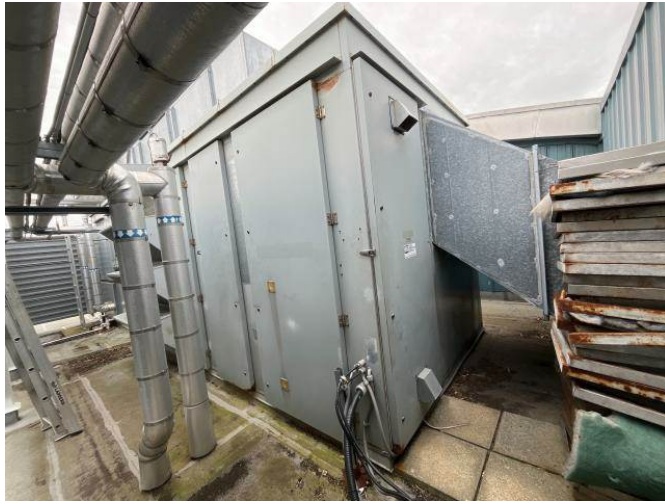
Photo #16: Pool Air Handling-Dehumidification Unit

The pool air handling unit/dehumidification unit (AHU1) is in poor condition and requires replacement in the near future along with the heat recovery ventilator on top of the unit. The other three outdoor air handling units (AHU4, AHU5 and AHU6) are also expected to

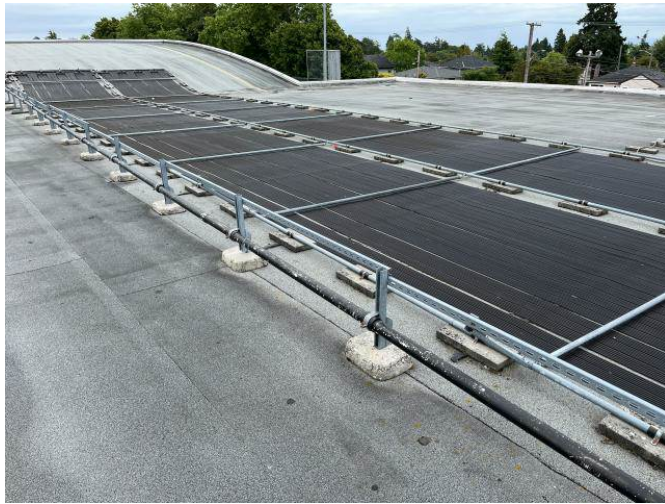
Photo #23: Solar Heat Recovery System

The solar heat recovery system was not in operation at the time of our review. We understand there are cracked pipes that require repair prior to being able to restart the system. The solar system is believed to be about 10 years old so allowances for additional component replacements have also been included.

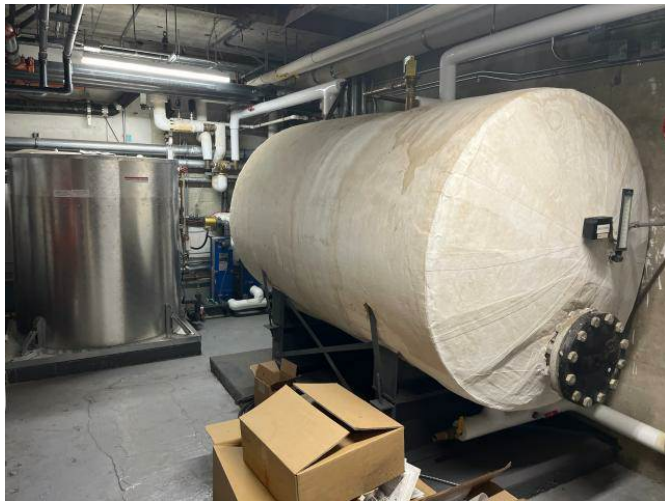
Photo #27: Domestic Water Storage Tank

The domestic hot water storage tank is original from 1974. A budget for replacement with multiple smaller storage tanks is included.
