**KERR WOOD LEIDAL**  
consulting engineers

# Inflow and Infiltration Masterplan

Final Report  
August 24, 2021  
KWL Project No. 0601.010

Prepared for:  
Township of Esquimalt

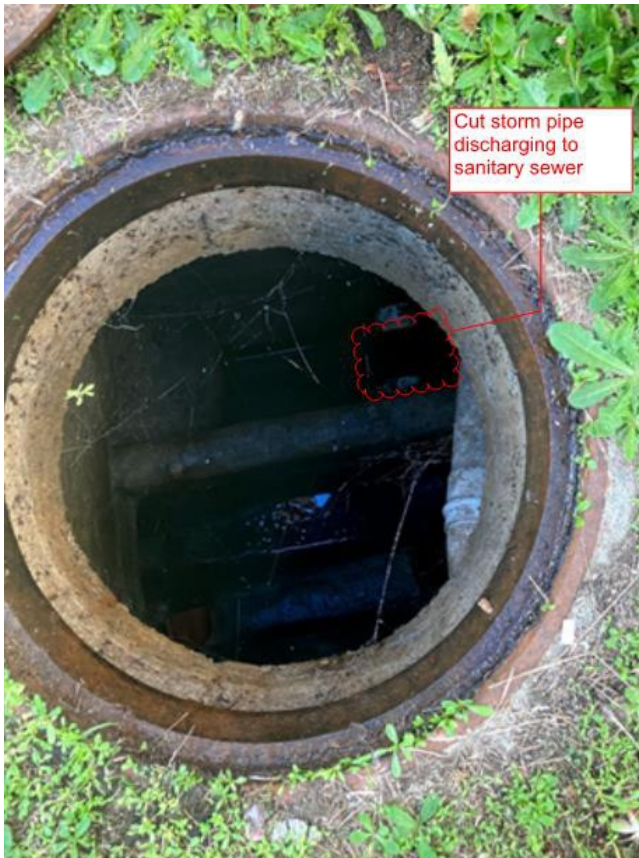
A direct storm to sewer connection was located in combined manhole SMH0686 at the Archie Browning Sport Centre outside the east entrance. The service appears to have previously been piped across the sewer main and into the storm main but appears to have been cut off inside the manhole, no flow was noted during the inspection however KWL returned to the site during a light rainfall event and noted that the pipe was flowing. The origin of the service connection is unknown but could represent a significant source of I&I if connected directly to roof or parking lot drains.

**Figure 5-2: Combined Manhole at Archie Browning Sport Centre**

The connection would represent a 0.6 – 0.8 L/s flow during 5-year 24-hour rainfall event assuming between 0.5 – 0.7 ha of roof or parking lot area is connected.

The direct connection noted above and found through our field investigation should be redirected where possible and the sewers at 847 Dunsmuir Road should be investigated to determine if they can be abandoned.

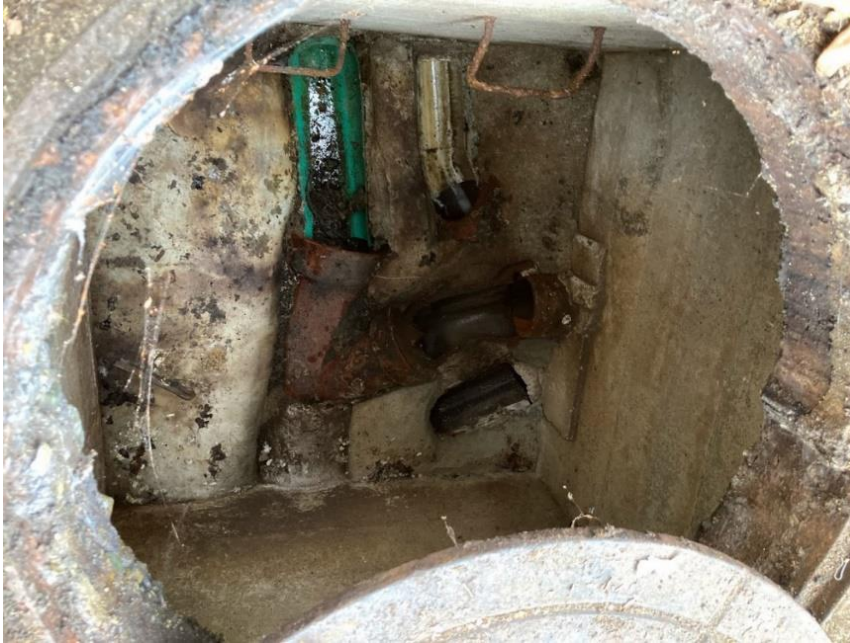
Manhole SMH0320 located in the backyard of residence at 861 Kindersley Road includes several inlet pipes (cannot determine which is sewer and which is storm) into the manhole with a single outlet into the sewer system.

**Figure 5-3: Combined Manhole at 861 Kindersley Road**

The cross connection would represent up to 0.1 – 0.3 L/s during 5-year 24-hour rainfall event assuming between 0.1 – 0.4 ha area connected.

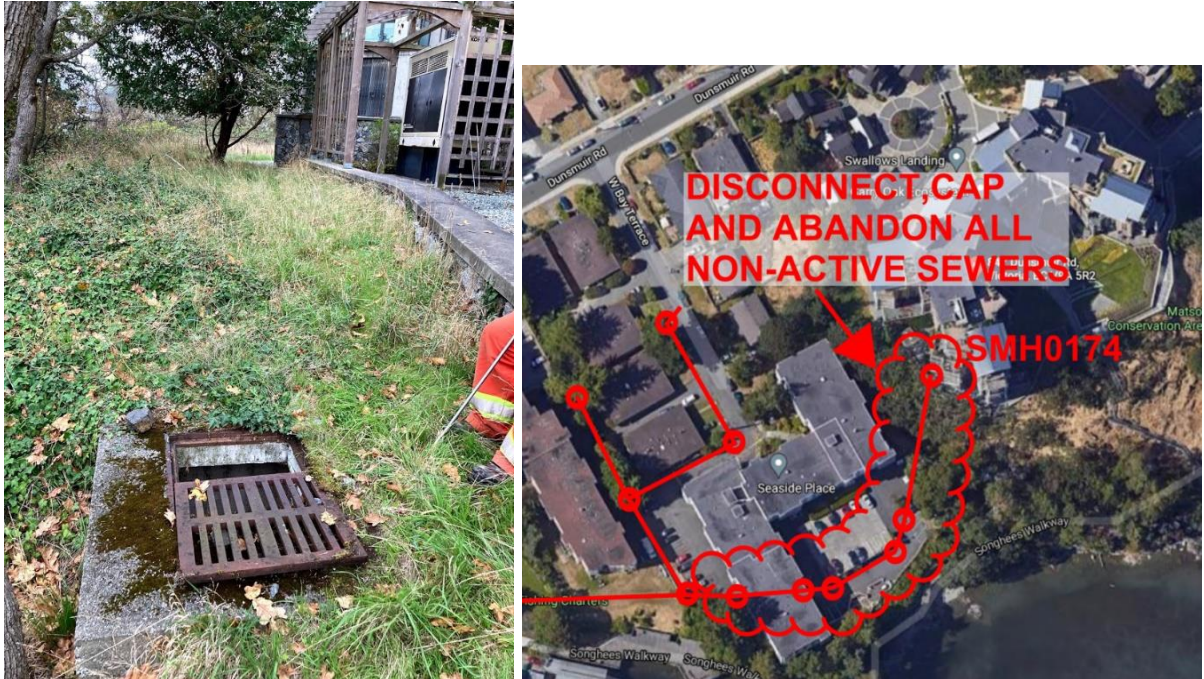
Manhole SMH0174 is a combined manhole that appears to be at the top end of an abandoned sewer main. The main passes through the adjacent property, 531 West Bay Terrace. SMH0174 has a grated lid and picks up a small, grassed drainage area.

Figure 5-4: Area Draining to Combined Manhole at 847 Dunsmuir Road

We recommend that the Township determine where the active services are located for 847 Dunsmuir Road and 531 West Bay Terrace and disconnect, cap, and abandon all non-active sewers as they are a likely source of I&I.

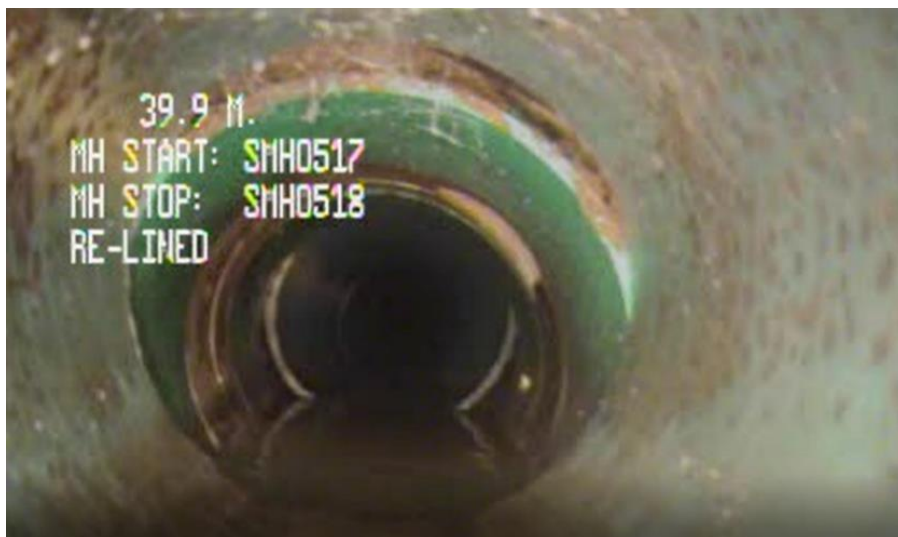
- Cut-outs can be non-circular and too much material is sometimes removed. This sometimes includes damage, holes cut into newly installed PVC wyes, installed just prior to lining. The skill of the operator and the equipment and sharpness of tools used play a large roll.
- Service cut-outs can be a source of I&I. I&I can come from either the existing lateral interface or from the void space between the host pipe and liner – the host pipe continues to be leaky and water is funnelled towards the service cut-out locations.
- There is no structural connection to the host pipe if the service is only cut-out.
- Where a tee is cut into a lined sewer for a new services or replacement, joints are added and sagging of the cut-in wye is common. This creates hydraulic and maintenance issues as well as new sources of I&I.

Figure 6-3: A New Wye Cut-in to a CIPP Lined Sewer that has Sagged (Picture 1)

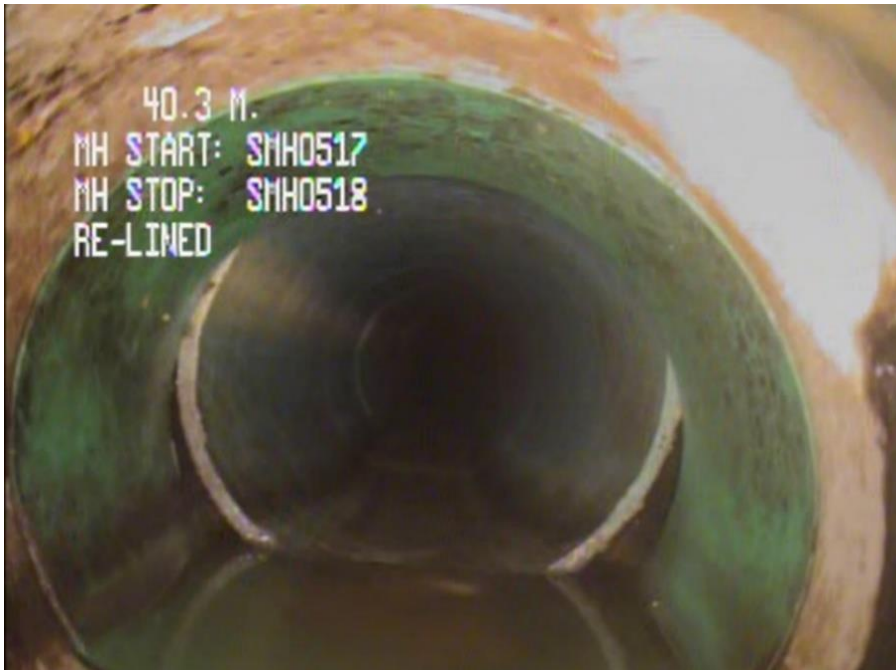
Figure 6-4: A New Wye Cut-in to a CIPP Lined Sewer that has Sagged (Picture 2)

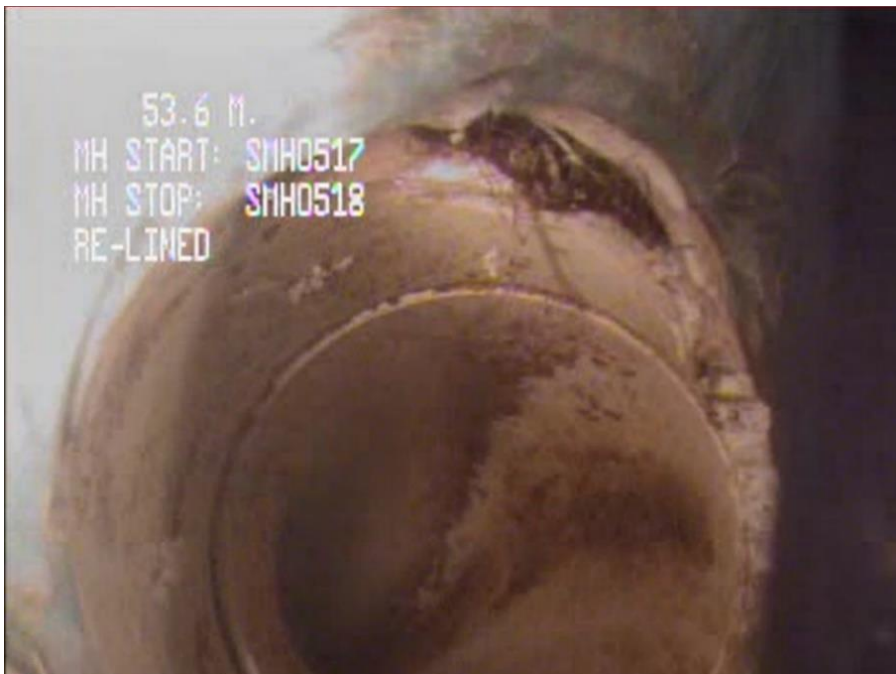
Figure 6-5: Overcut Lateral Connection with Damage to the Lateral and Root Intrusion

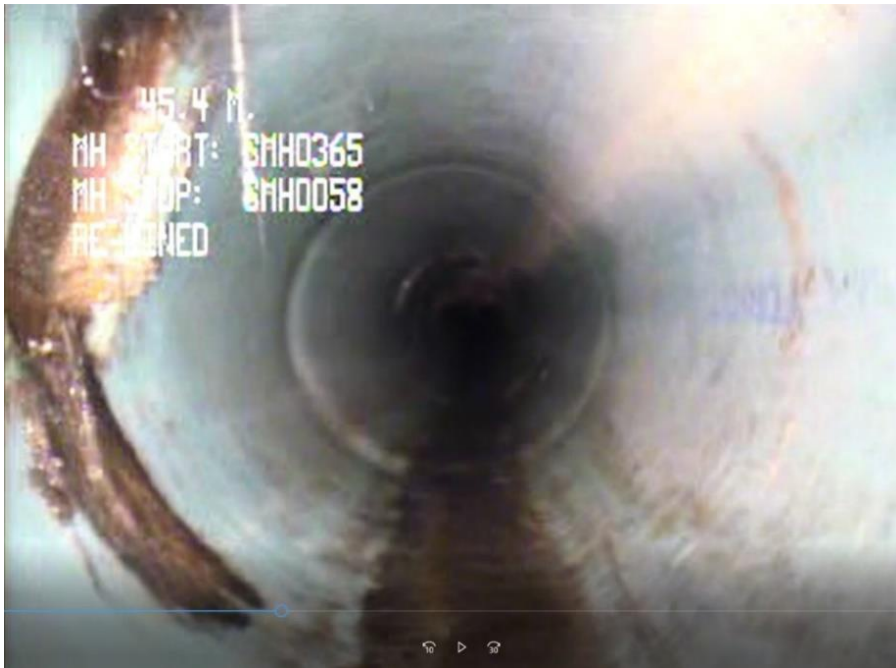
Figure 6-6: I&I at a Lateral Cutout (Picture 1)

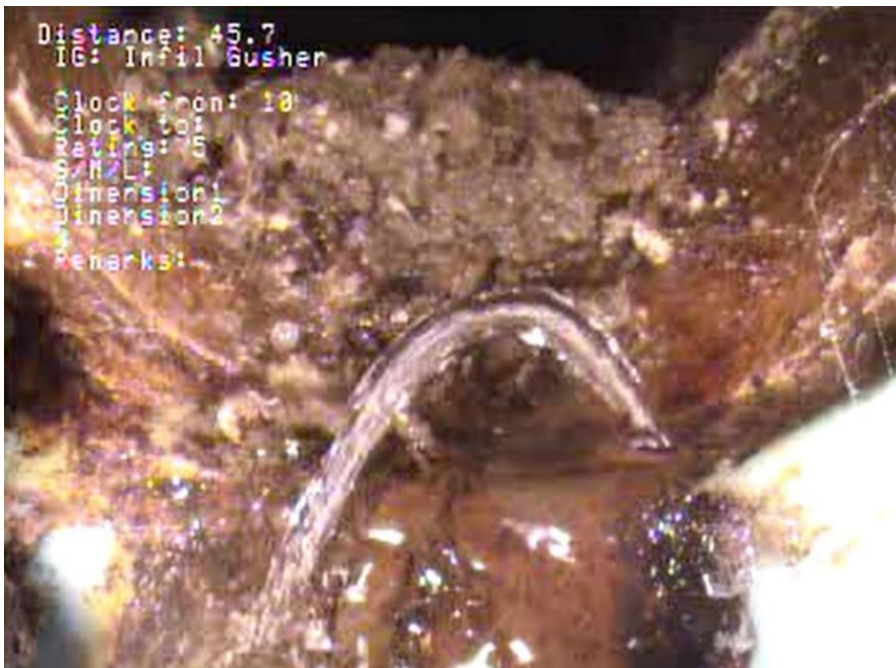
Figure 6-7: I&I at a Lateral Cutout (Picture 2)

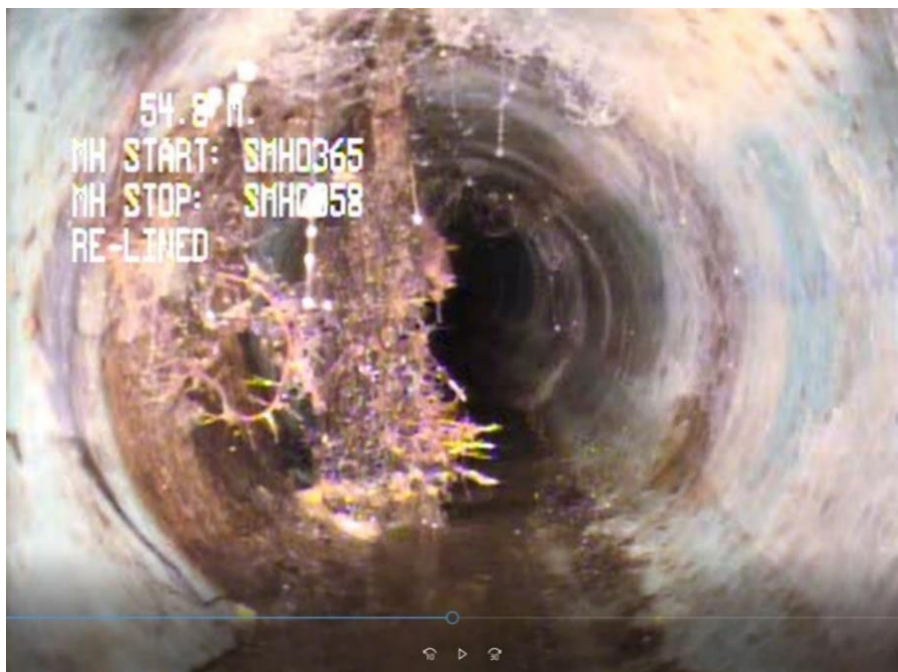
**Figure 6-8: Root Intrusion at a Lateral Interface – No Structural Connection of Lateral and Main**

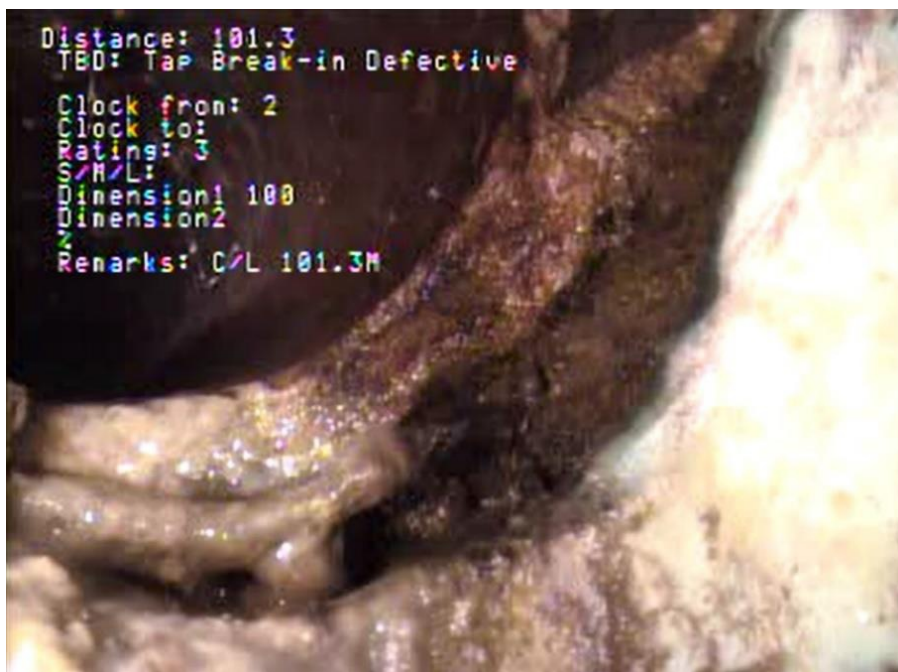
**Figure 6-9: Soil Visible at a Lateral Interface – No Structural Connection of Lateral and Main**

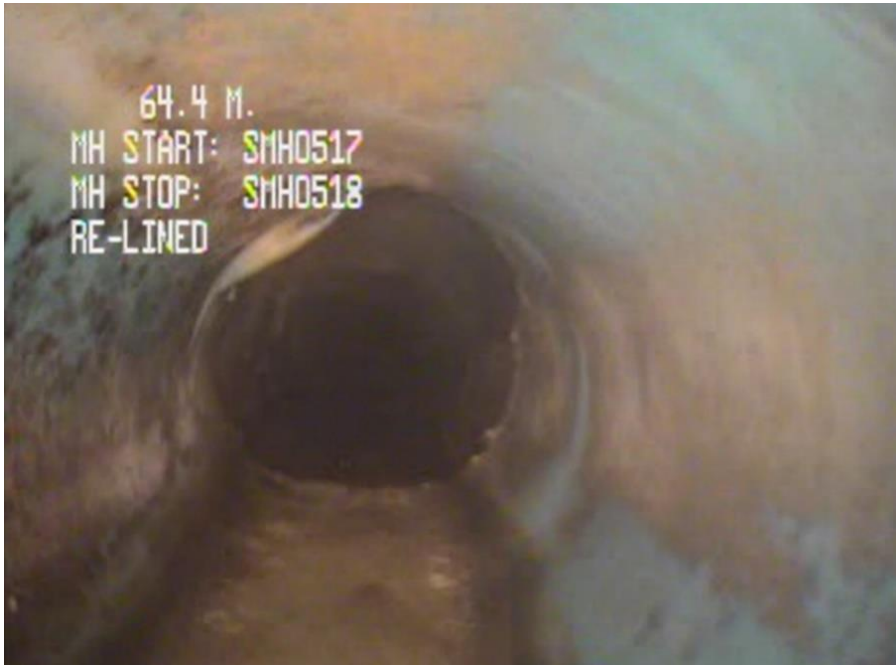
It is also noted that the PACP system includes codes for liner wrinkles, that in our opinion do not affect the structural integrity of the line if they passed original inspection during construction. The PACP

scoring index assigns a Class 4 structural defect to these codes. We reviewed a few lined pipes with high defect scores and found the wrinkles to be insignificant. Example images are provided below:

Figure 6-10: Liner Wrinkle at Manhole Interface – Not Affecting Structural Integrity or Hydraulics

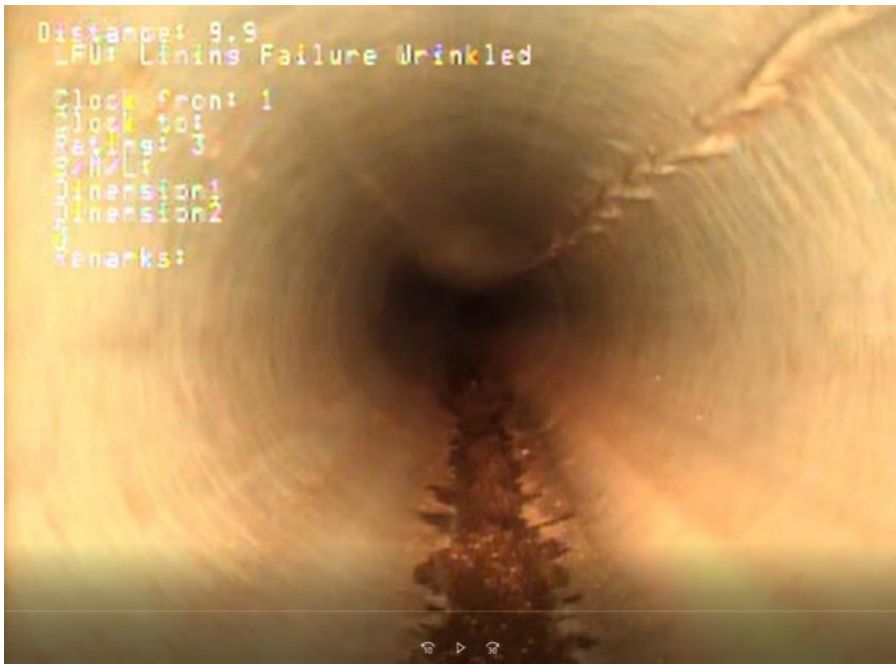
Figure 6-11: Liner Wrinkle – Not Affecting Structural Integrity or Hydraulics

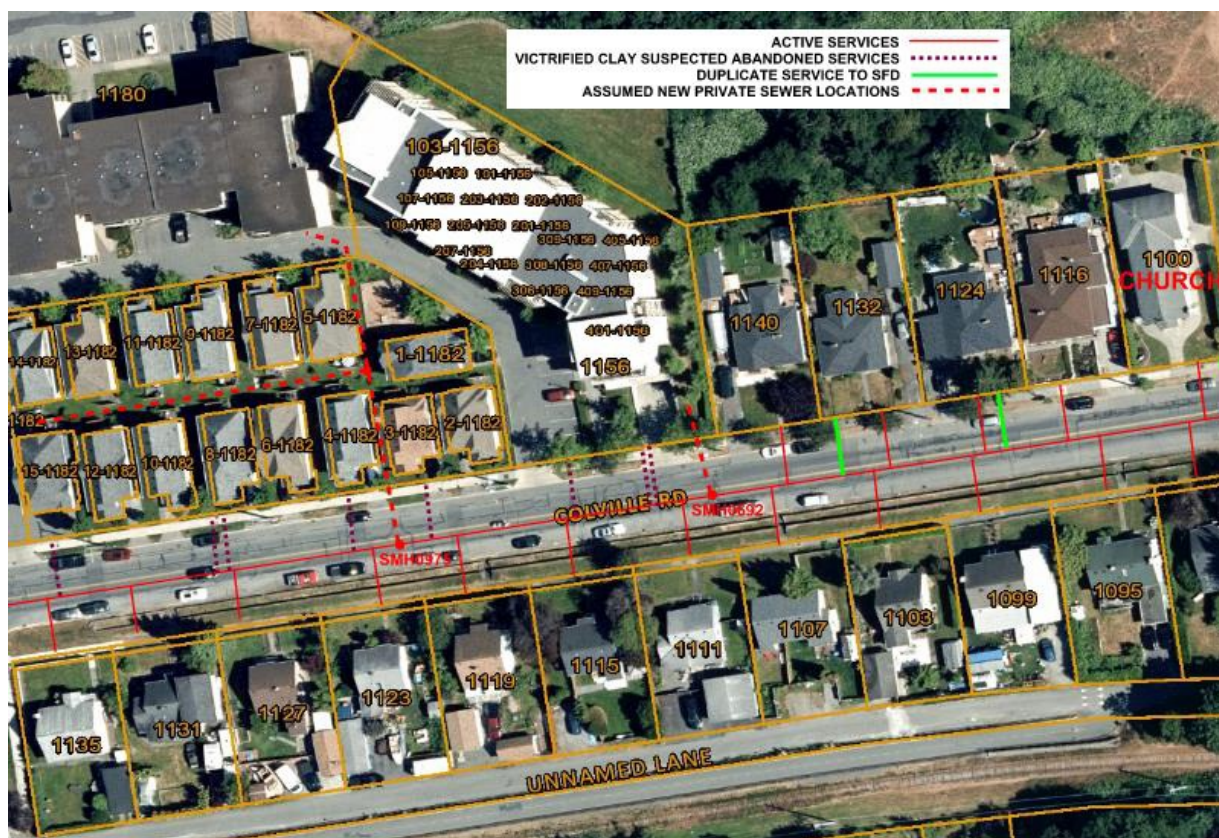
Additionally, a review of service locations was completed using available CCTV along Colville Road to determine the number of services fronting each lot. Duplex and triplex lots were assumed to have two legitimate sanitary services as this was seen in the number of services to these lots. Figure 7-4 shows the 1100 block of Colville Road where there are suspected abandoned services that are contributing to I&I as well as possible direct connections.

**Figure 7-4: Mapped Sewer Services along 1100 Block of Colville Road**

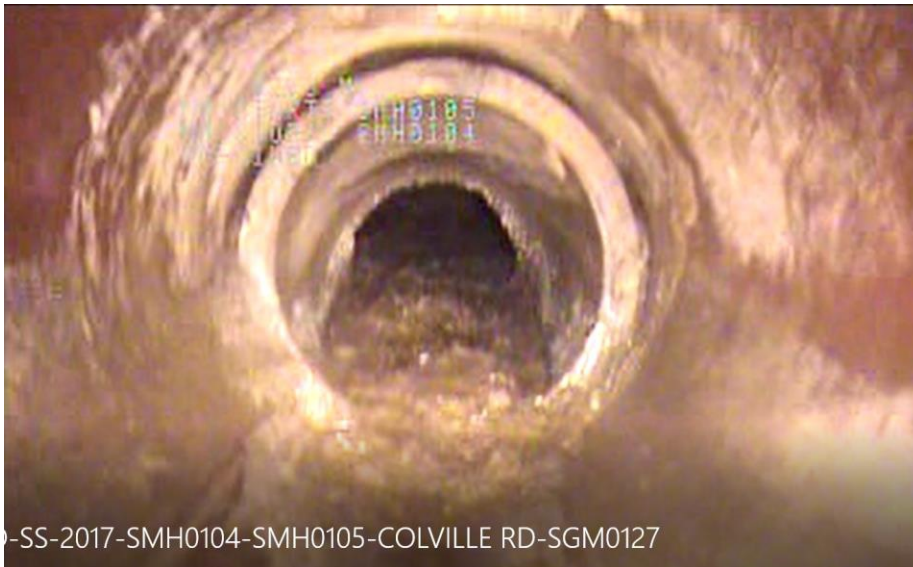
We note that the end of line manhole, pictured in Figure 7-5 below, appears to be failed and is full of dirt and there does not appear to be a purpose for the sewer from SMH0493 to SMH0105 that crosses the soccer field. These are potential sources of some of the GWI upstream of 1215 Colville Road manhole.

Figure 7-5: End of Line Colville Manhole SMH0104 – Full of Dirt
