Inflow and Infiltration Masterplan

Final Report August 24, 2021 KWL Project No. 0601.010

Prepared for: Township of Esquimalt

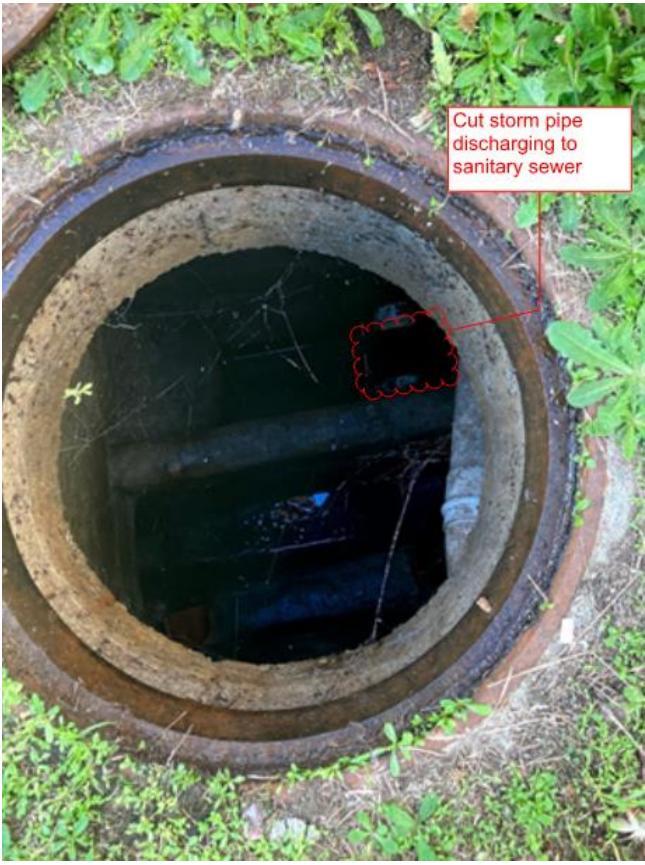
Figure 5-2: Combined Manhole at Archie Browning Sport Centre

A direct storm to sewer connection was located in combined manhole SMH0686 at the Archie Browning Sport Centre outside the east entrance. The service appears to have previously been piped across the sewer main and into the storm main but appears to have been cut off inside the manhole, no flow was noted during the inspection however KWL returned to the site during a light rainfall event and noted that the pipe was flowing. The origin of the service connection is unknown but could represent a significant source of I&I if connected directly to roof or parking lot drains.

The connection would represent a 0.6 - 0.8 L/s flow during 5-year 24-hour rainfall event assuming between 0.5 - 0.7 ha of roof or parking lot area is connected.

The direct connection noted above and found through our field investigation should be redirected where possible and the sewers at 847 Dunsmuir Road should be investigated to determine if they can be abandoned.

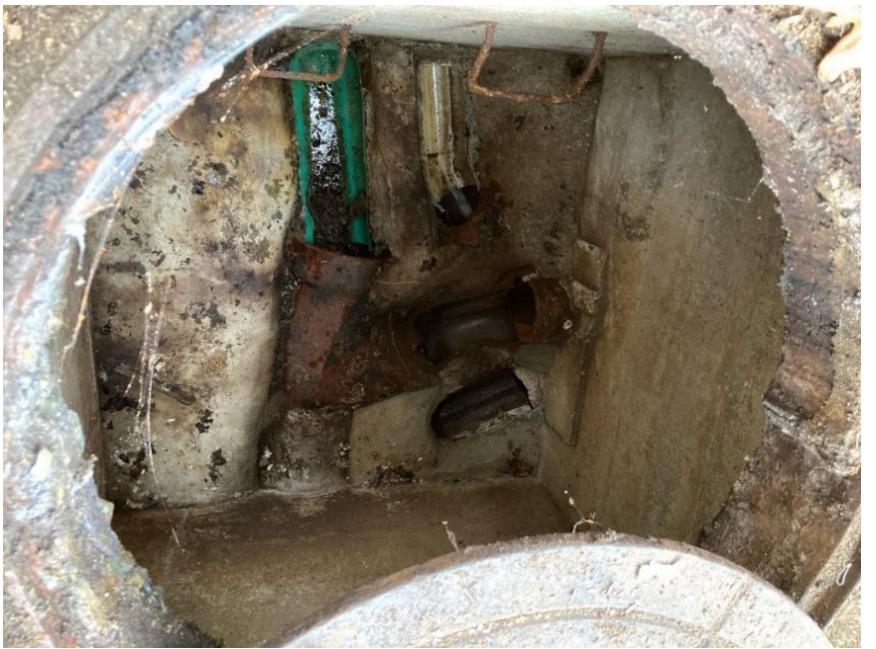
Figure 5-3: Combined Manhole at 861 Kindersley Road

The cross connection would represent up to 0.1 - 0.3 L/s during 5-year 24-hour rainfall event assuming between 0.1 - 0.4 ha area connected.

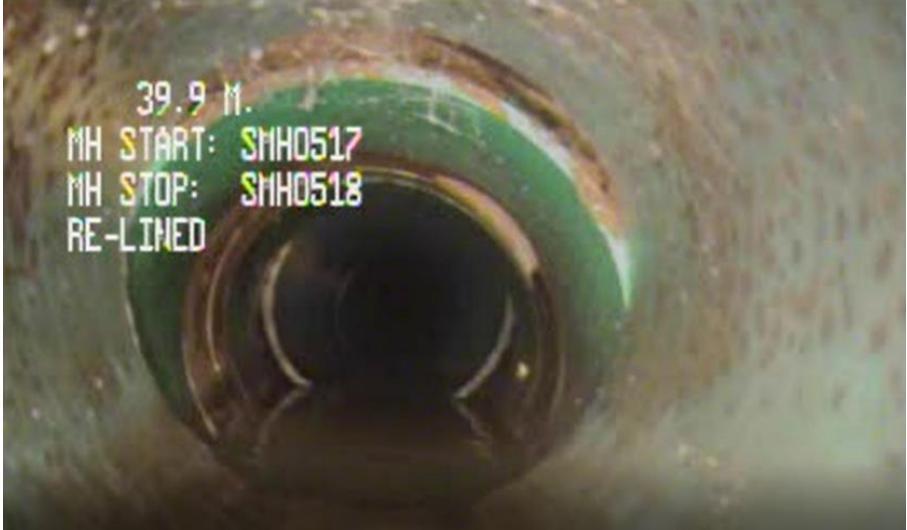
Figure 6-3: A New Wye Cut-in to a CIPP Lined Sewer that has Sagged (Picture 1)

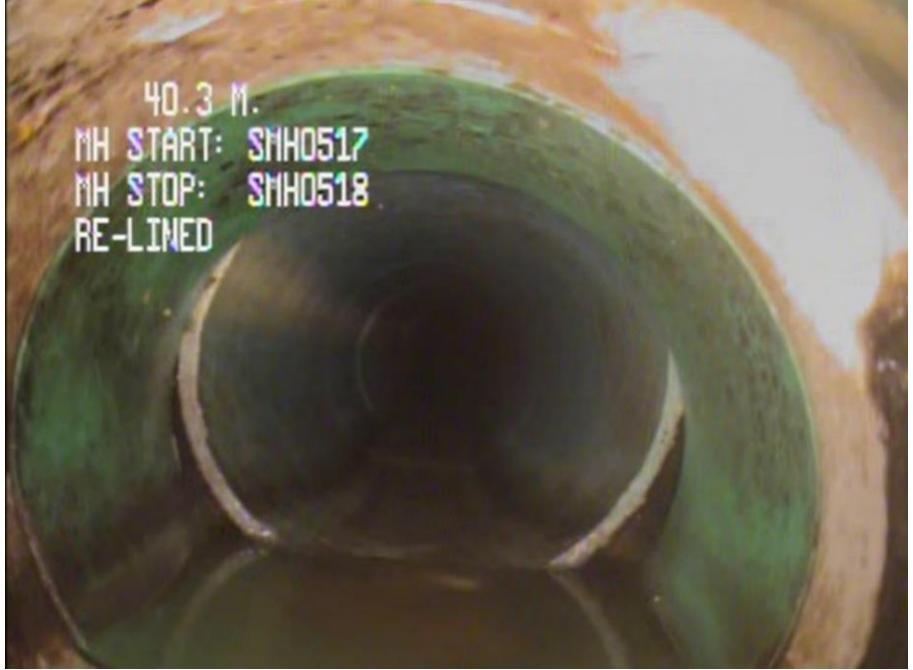
Figure 6-4: A New Wye Cut-in to a CIPP Lined Sewer that has Sagged (Picture 2)

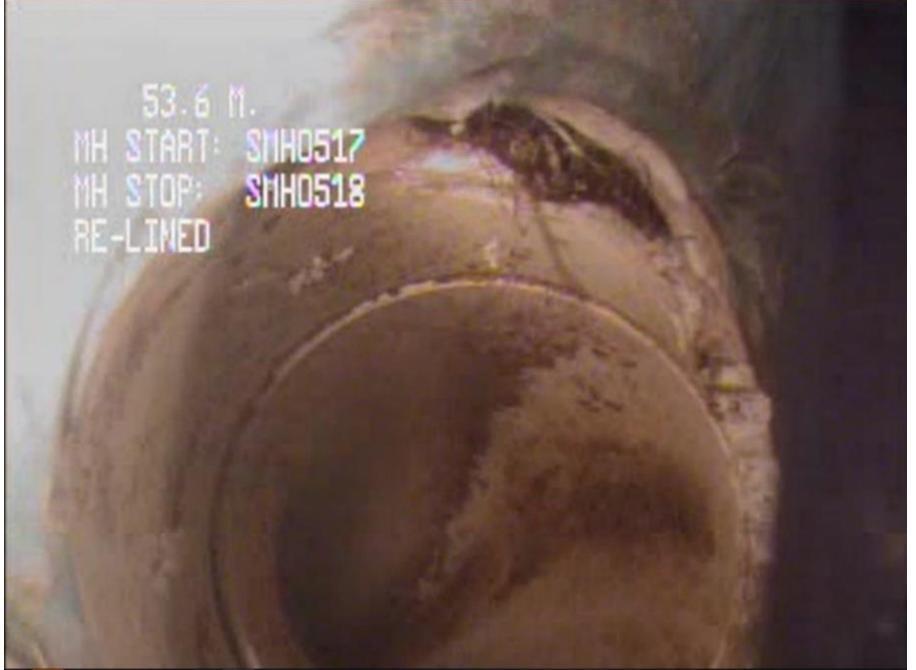
Figure 6-5: Overcut Lateral Connection with Damage to the Lateral and Root Intrusion

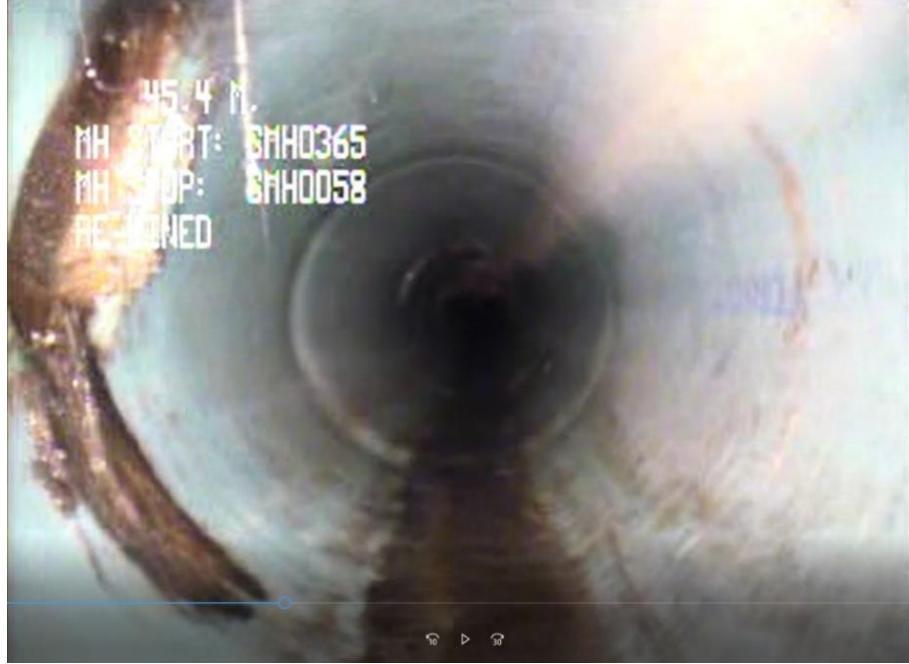
Figure 6-6: I&I at a Lateral Cutout (Picture 1)

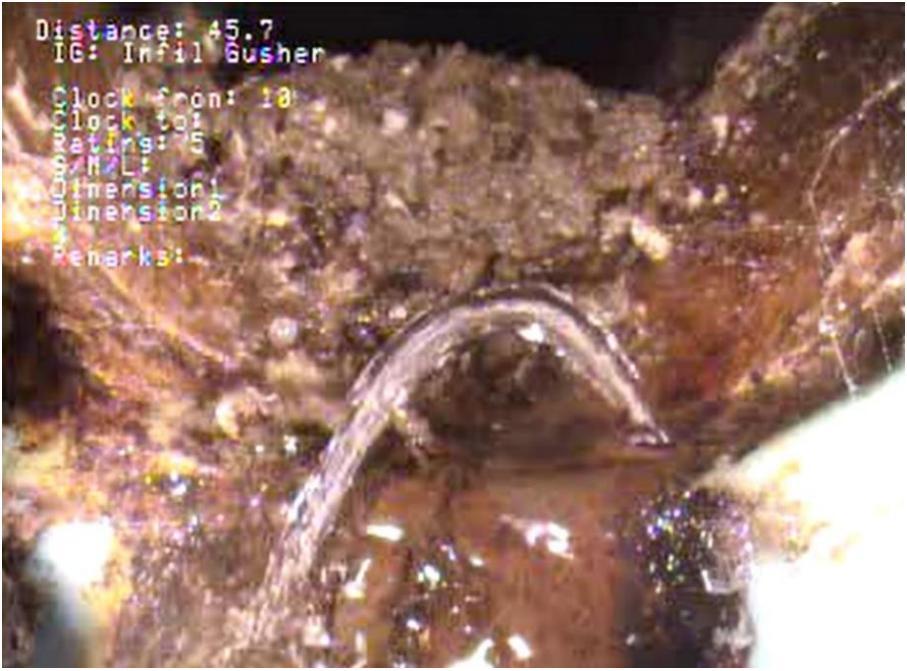
Figure 6-7: I&I at a Lateral Cutout (Picture 2)

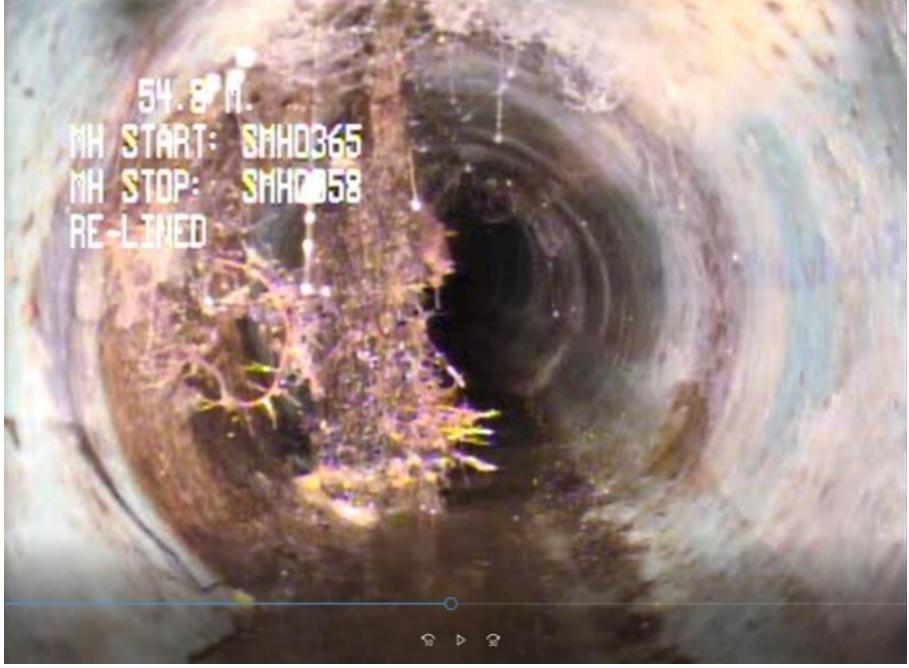
Figure 6-8: Root Intrusion at a Lateral Interface – No Structural Connection of Lateral and Main

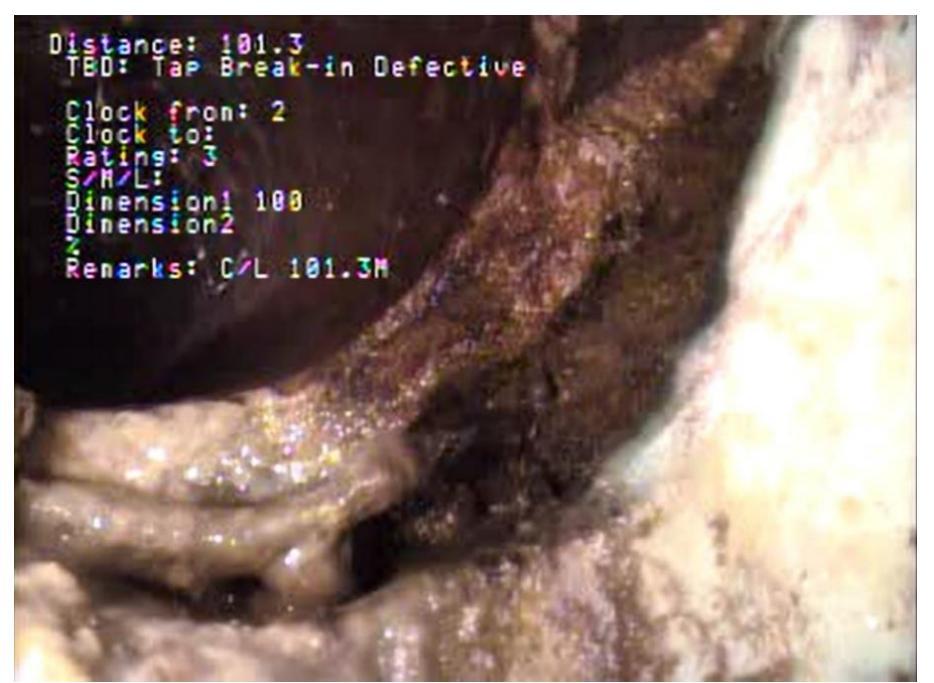
Figure 6-9: Soil Visible at a Lateral Interface – No Structural Connection of Lateral and Main

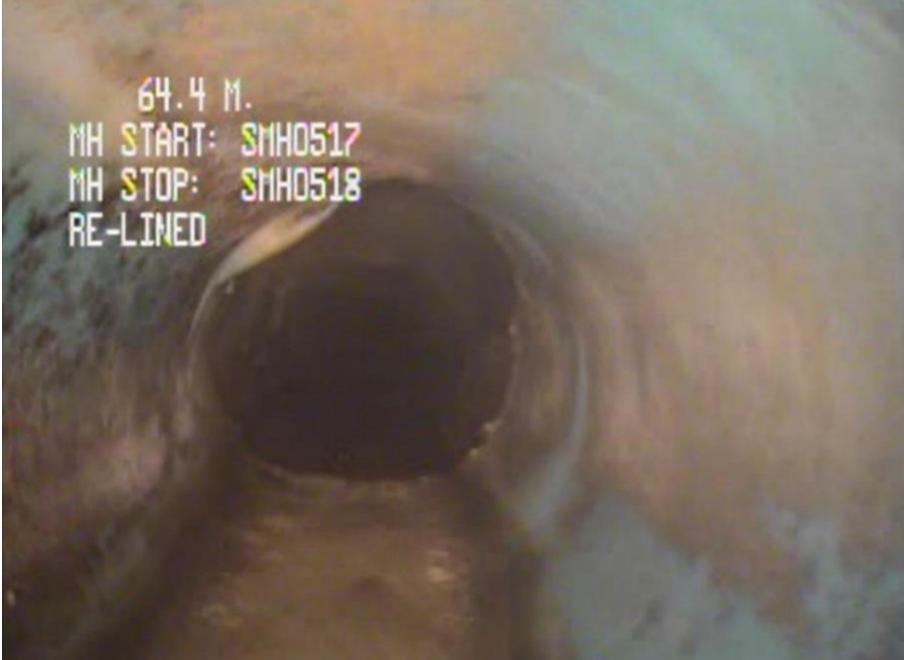
It is also noted that the PACP system includes codes for liner wrinkles, that in our opinion do not affect the structural integrity of the line if they passed original inspection during construction. The PACP

scoring index assigns a Class 4 structural defect to these codes. We reviewed a few lined pipes with high defect scores and found the wrinkles to be insignificant. Example images are provided below:

Figure 6-10: Liner Wrinkle at Manhole Interface – Not Affecting Structural Integrity or Hydraulics

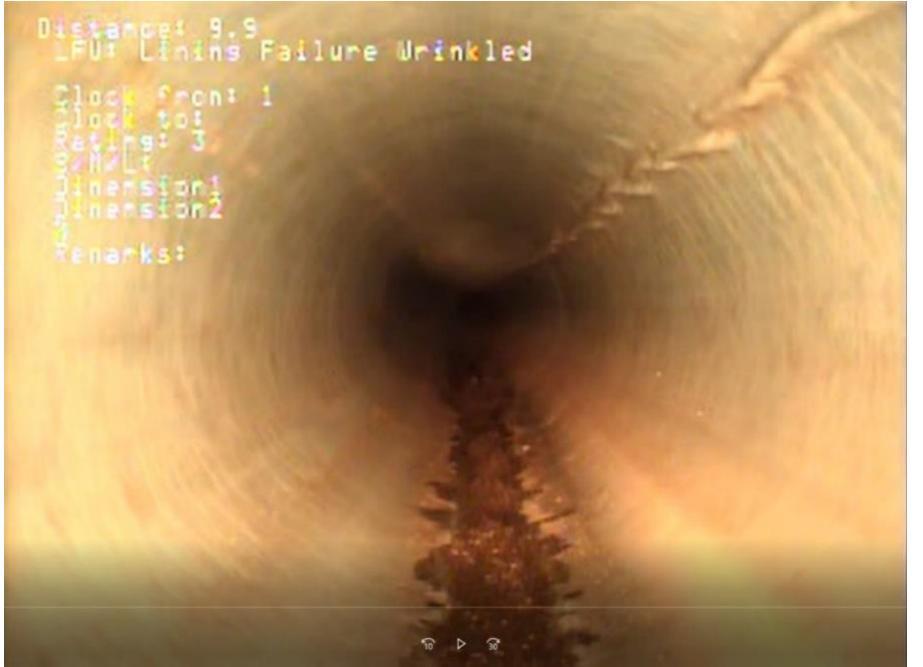
Figure 6-11: Liner Wrinkle – Not Affecting Structural Integrity or Hydraulics
