*Township of Esquimalt*

# **2013 Long Term Pavement Budgeting**

Date: August 2013  
Reference: H-V0117.00  
Status: Draft

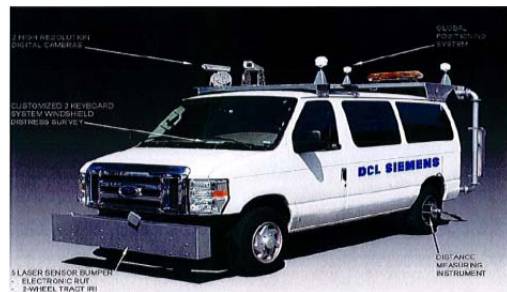
DCL Siemens owns and operates an International Cybernetics Corporation (ICC) data survey vehicle that simultaneously collects surface condition, roughness, rut, and GPS data streams. With the inclusion of the latest technology into the on-board systems, the data collection process has proven to be repeatable and extremely reliable. Details of this equipment can be supplied on request

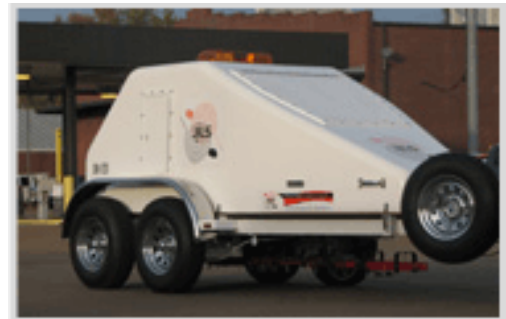
The structural strength data was collected with a JILS FWD 20 unit, which is a fully automatic, objective, and non-destructive testing device.

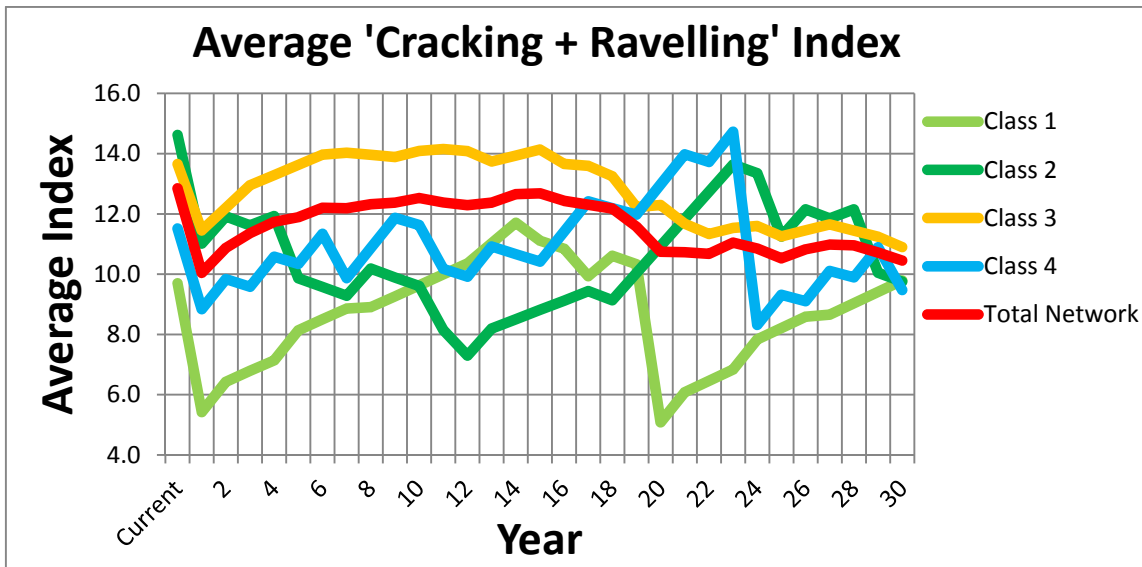
**Figure 8: 'Cracking + Ravelling' Index Change Over Time**

Figure 8 shows the models output of 'Cracking + Ravelling' index change over time.
