Inflow and Infiltration Masterplan

Final Report August 24, 2021 KWL Project No. 0601.010

Prepared for: Township of Esquimalt

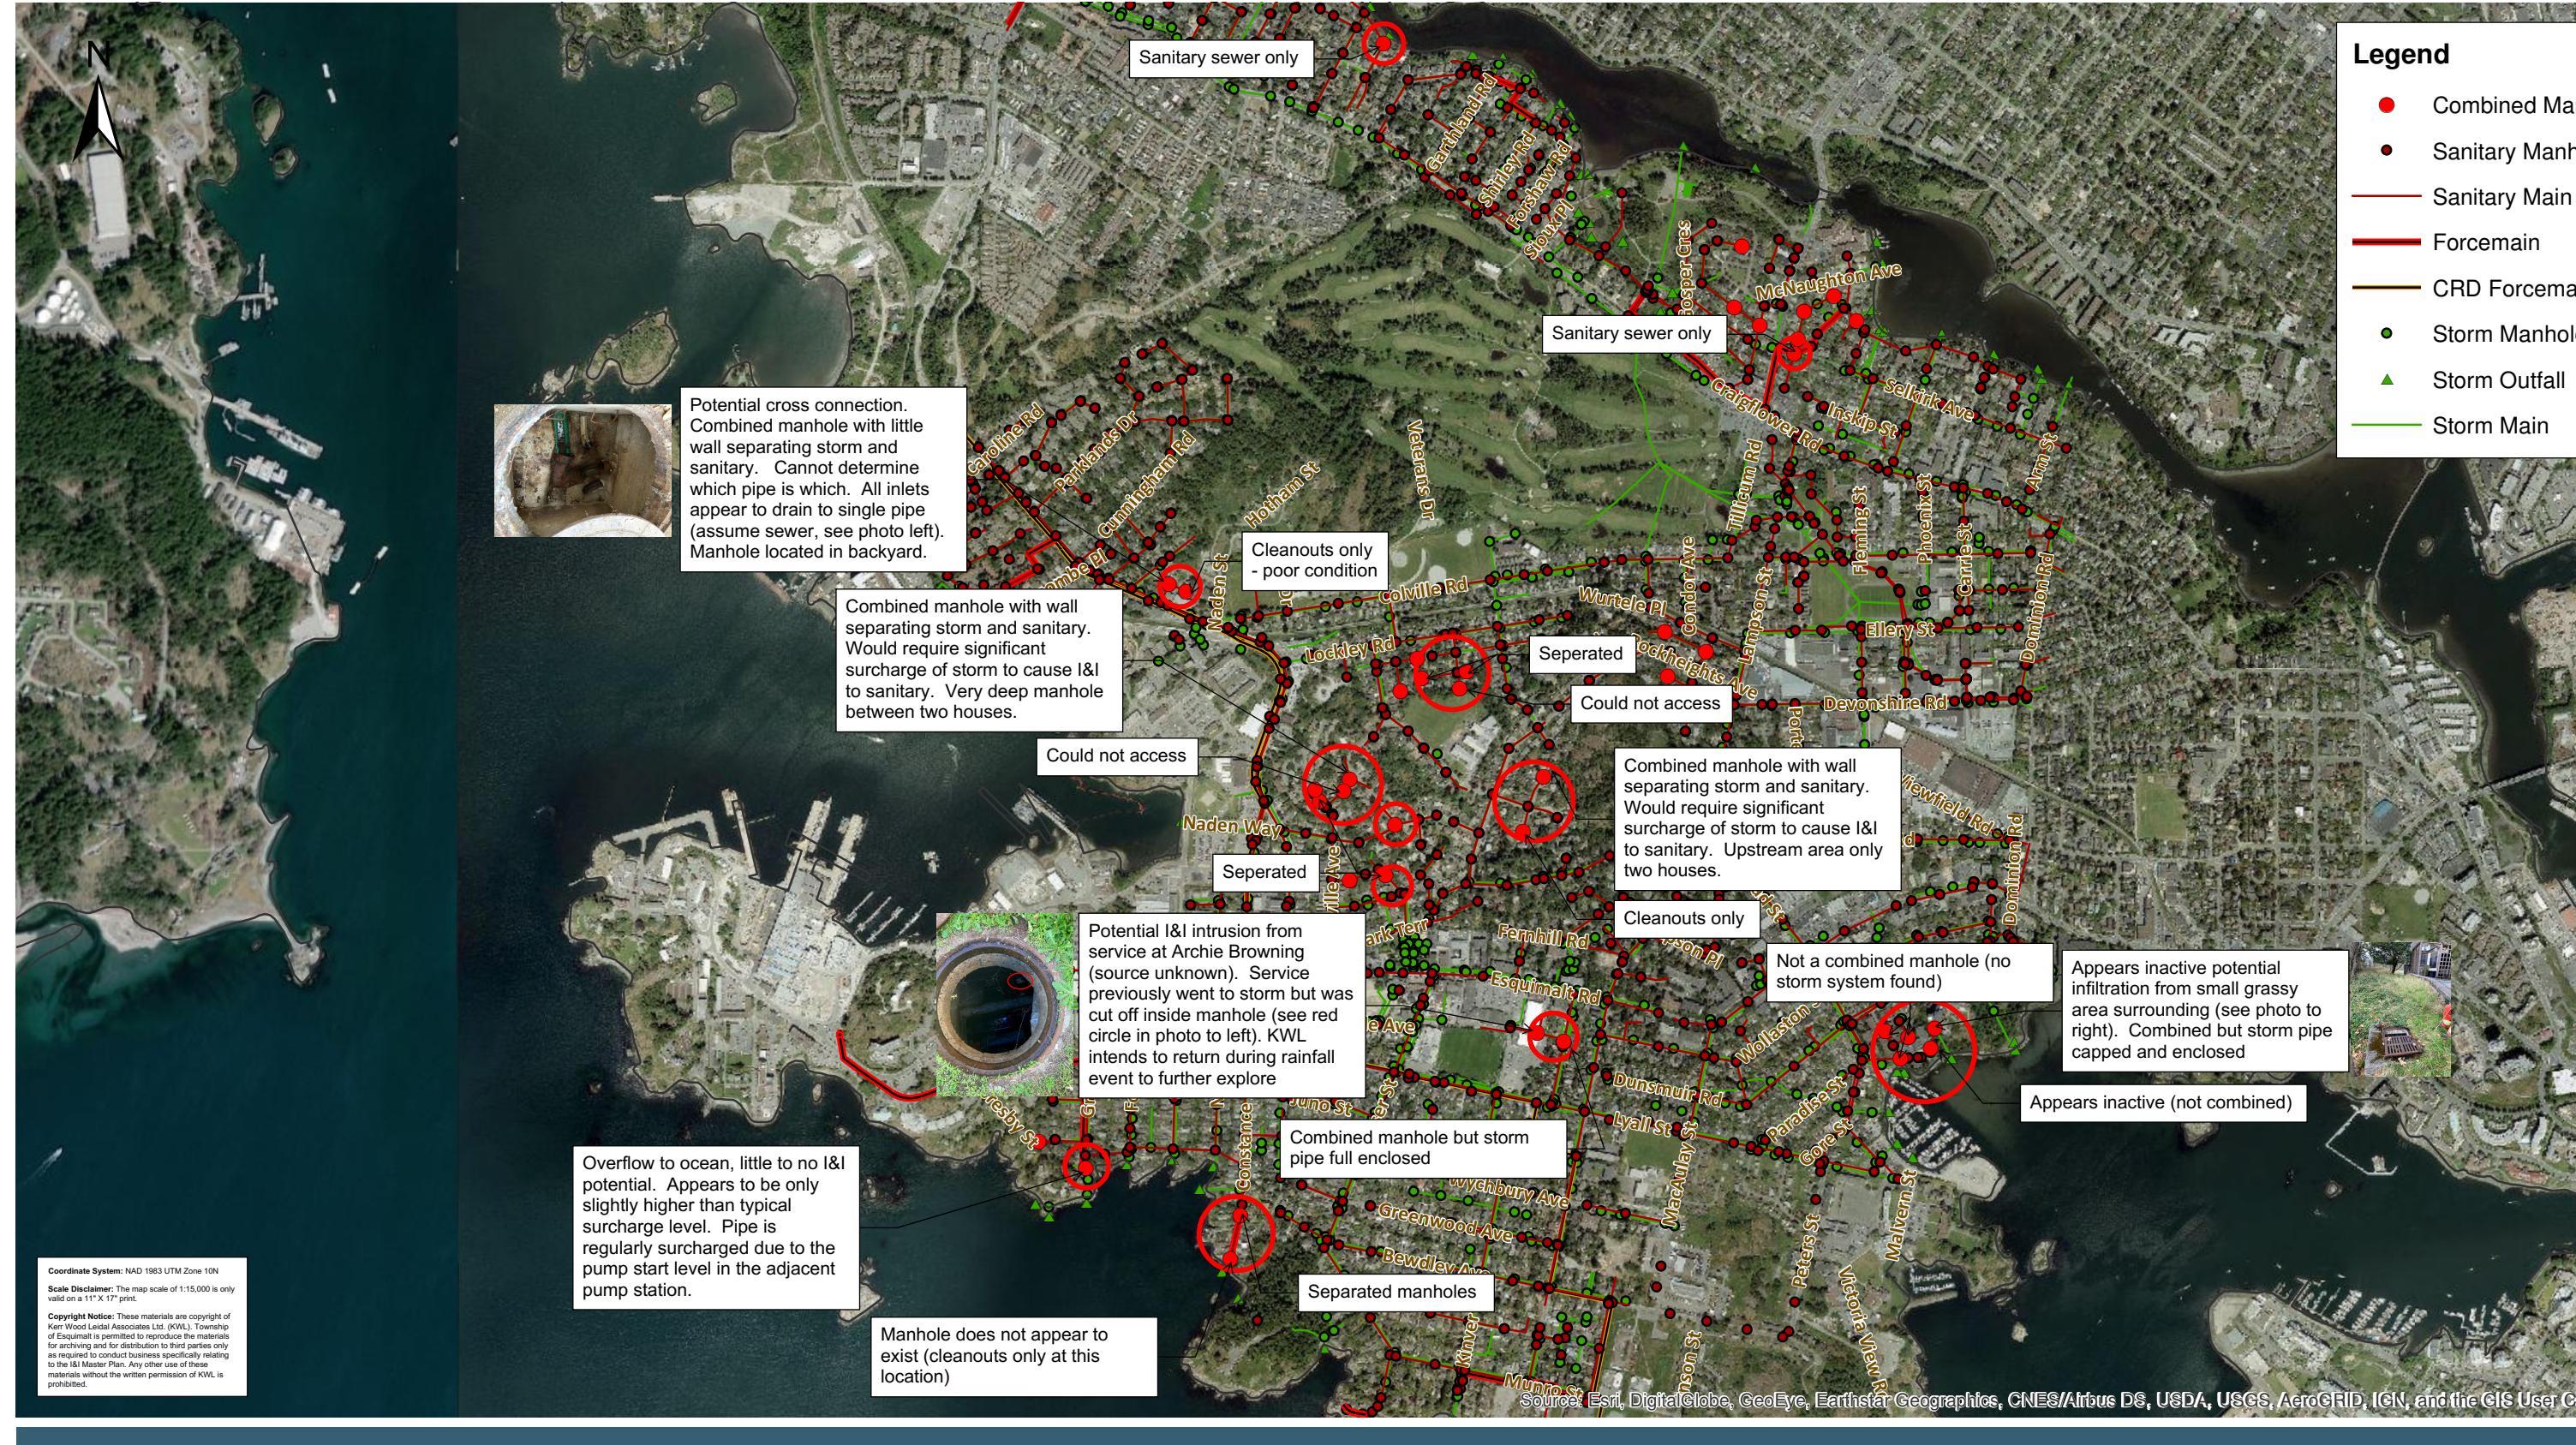
The combined manholes remaining are typically those that are most difficult to separate or are located at the top end of the system leaving very little I&I potential. The locations and findings of the combined manhole inspection are included in Figure 5-1 below.

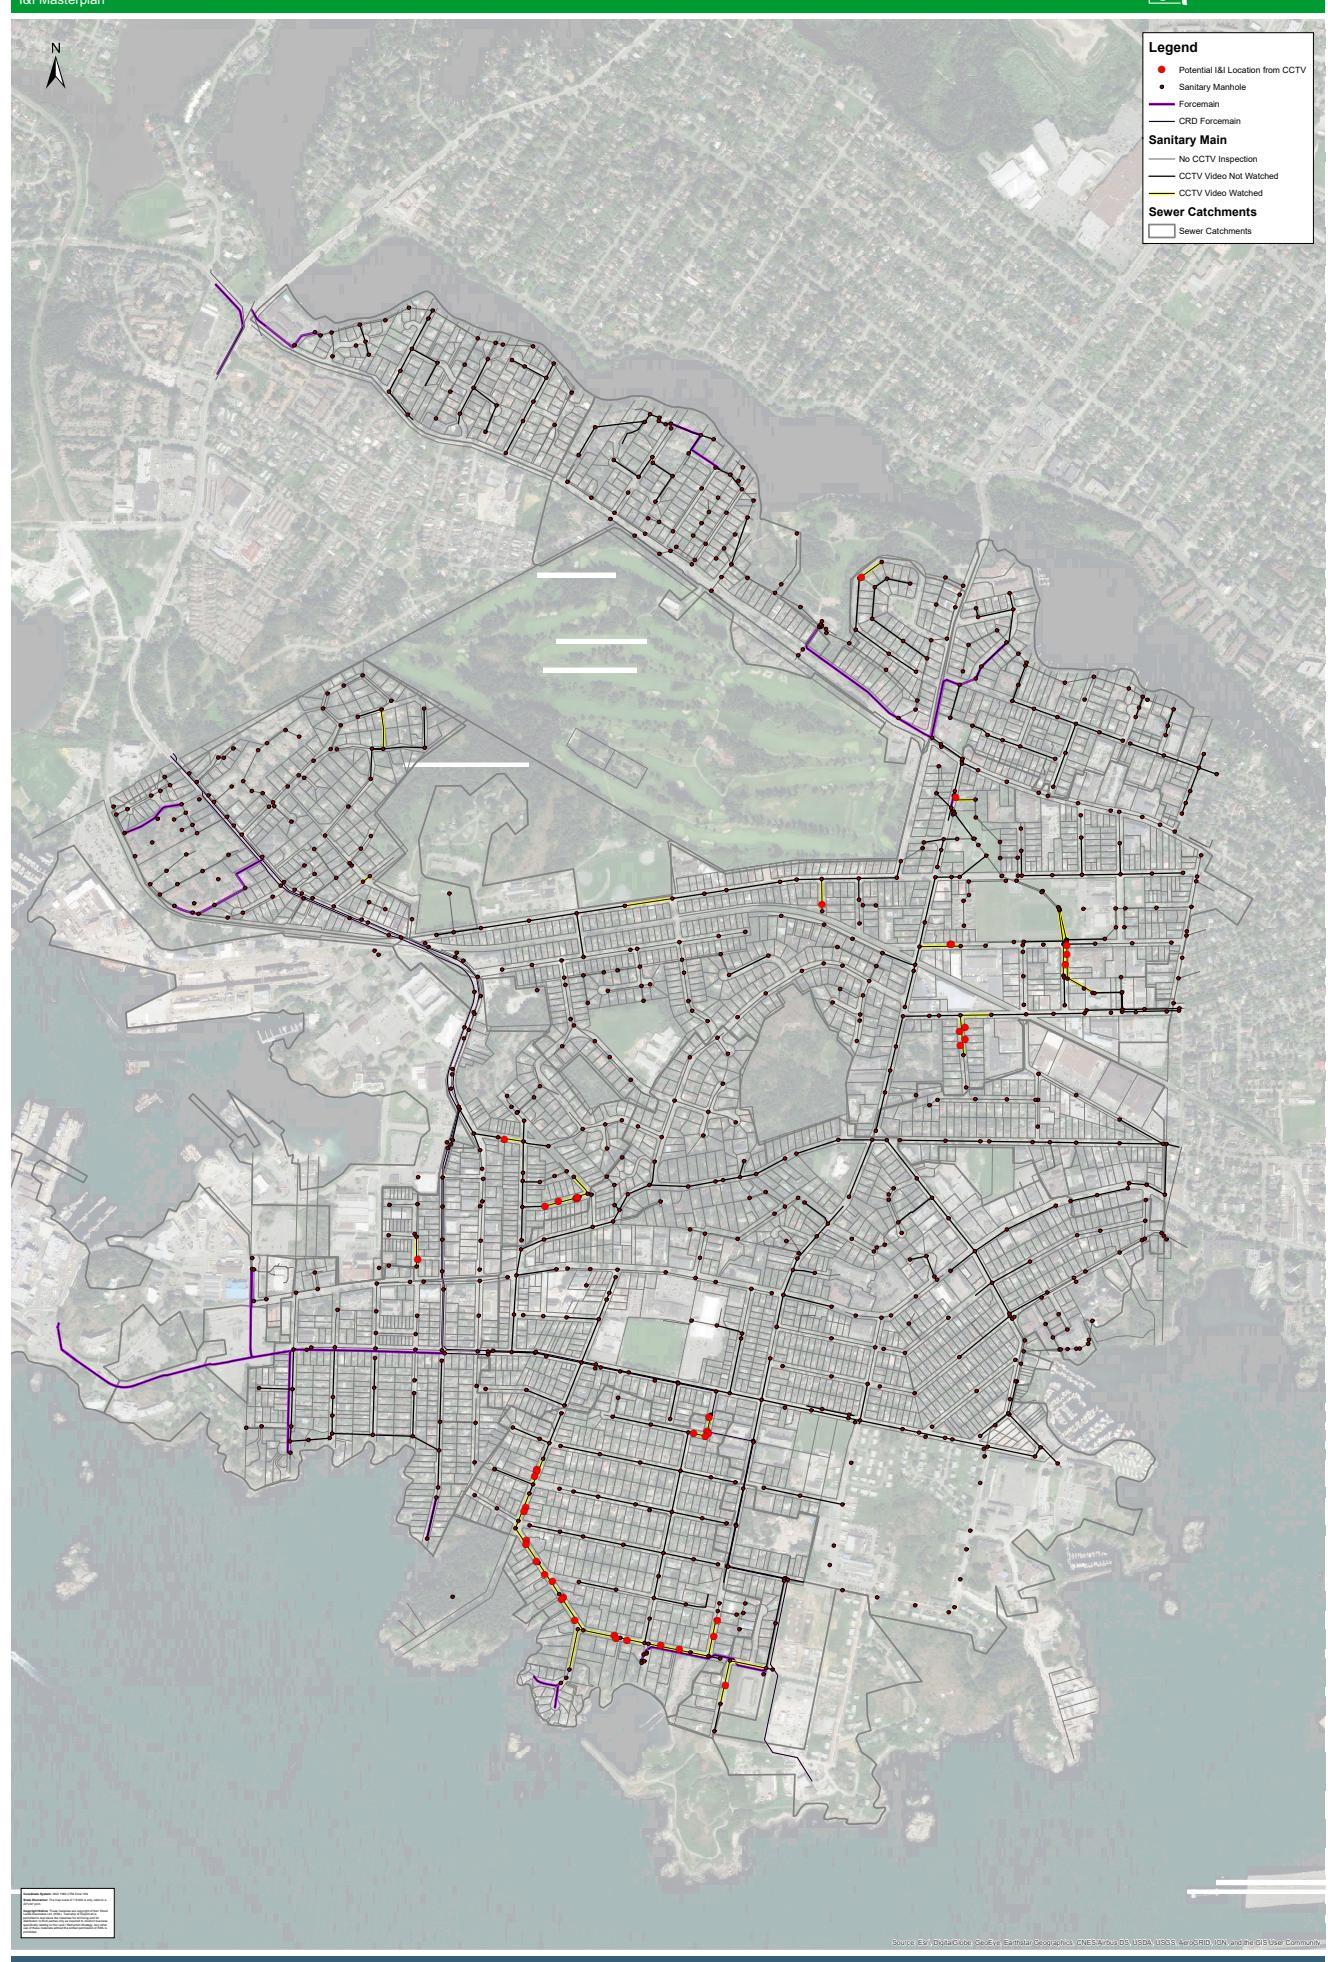
Figure 6-1 displays the areas where videos were reviewed (yellow highlight) as well as the laterals that were seen to have potential I&I flows. Somewhere between 25%-75% of laterals on a given line were seen to have some amount of background flow which corroborates the assumption that the majority of I&I is from service laterals.

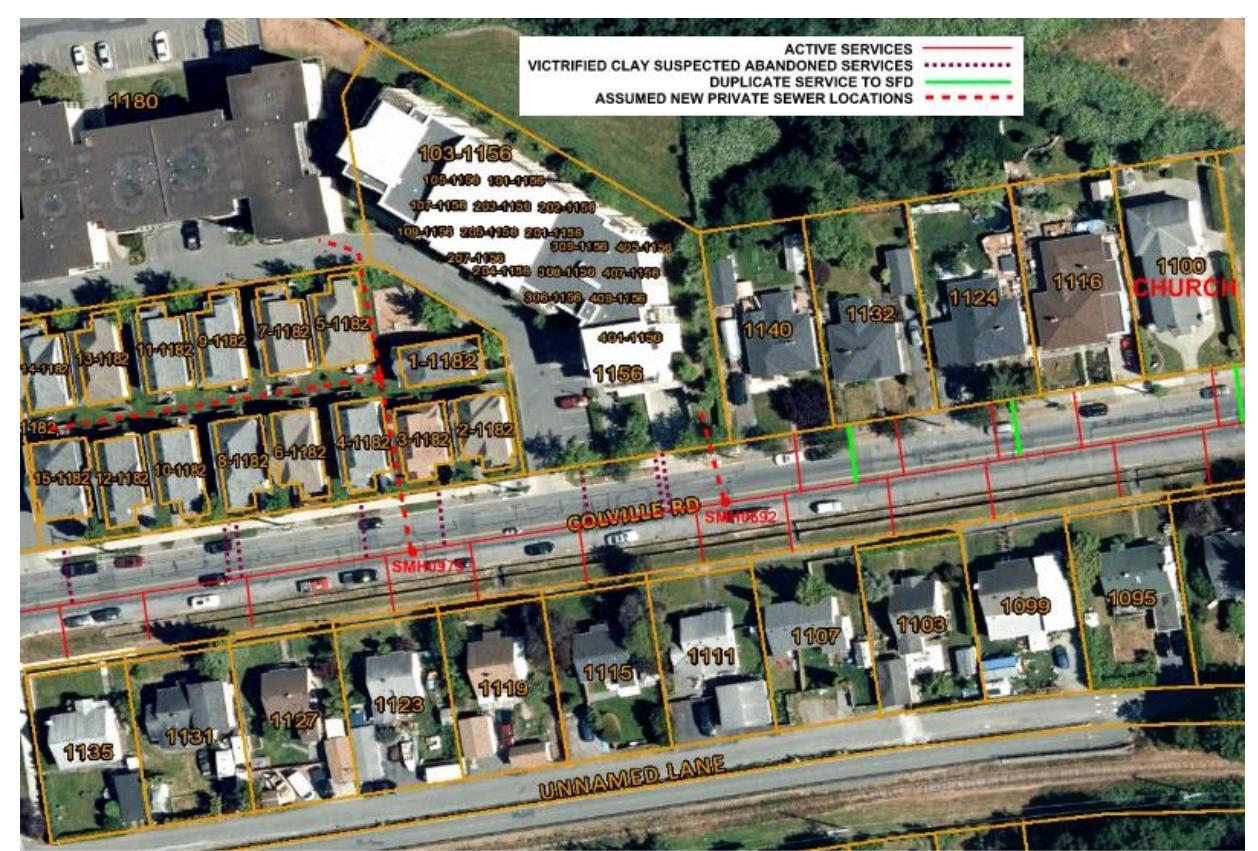
Figure 7-4: Mapped Sewer Services along 1100 Block of Colville Road

Additionally, a review of service locations was completed using available CCTV along Colville Road to determine the number of services fronting each lot. Duplex and triplex lots were assumed to have two legitimate sanitary services as this was seen in the number of services to these lots. Figure 7-4 shows the 1100 block of Colville Road where there are suspected abandoned services that are contributing to I&I as well as possible direct connections.

- 1. Colville Street: Ensure that inspectors look for smoke at the base hospital, at properties noted on Figure 7-4, and golf course lands as well as all other areas serviced by the sewer.
- 2. Uganda areas (as identified on Figure 7-6): Ensure inspectors investigate at the Gorge Point Condos and Gorge Point Pub as there are suspected cross connected CB's at this location. Ensure inspectors investigate the frontages of the waterfront properties. Smoke testing in this area could be affected by the nearby Uganda Pump Station and isolation from any overflows and combined manholes in the area would be required.
- Forshaw areas (as identified on Figure 7-6): Ensure to investigate locations noted on Glen Vale Road. Investigate the service at 940 Garthland that is tied into the sewer between SMH0092 and SMH0093.
