Project No. CA0053161.3566

**BUILDING CONDITION ASSESSMENT**  
**ARCHIE BROWNING SPORTS CENTRE**  
**1151 ESQUIMALT ROAD**  
**Victoria, British Columbia**

DECEMBER 16, 2025

**WSP Canada Inc.**

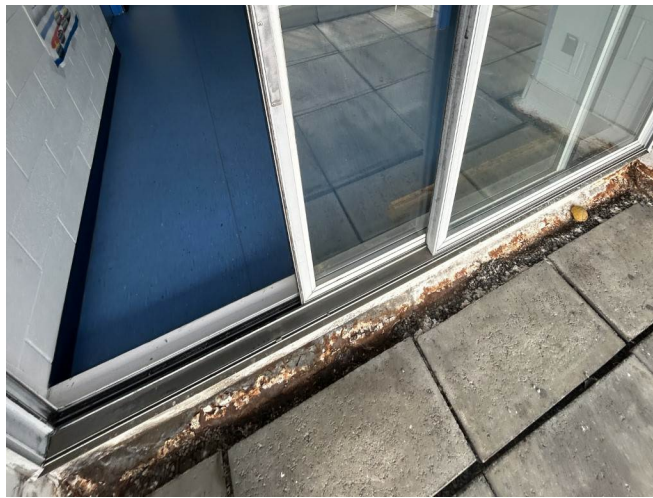
Photo #5: Balcony Door

The south balcony assembly shows signs of aging and water exposure, including corrosion at flashing and door frames, worn pavers, and rusting canopy supports. A full replacement is recommended, including membrane, pavers, flashing, sliding door, guardrails, and canopy.

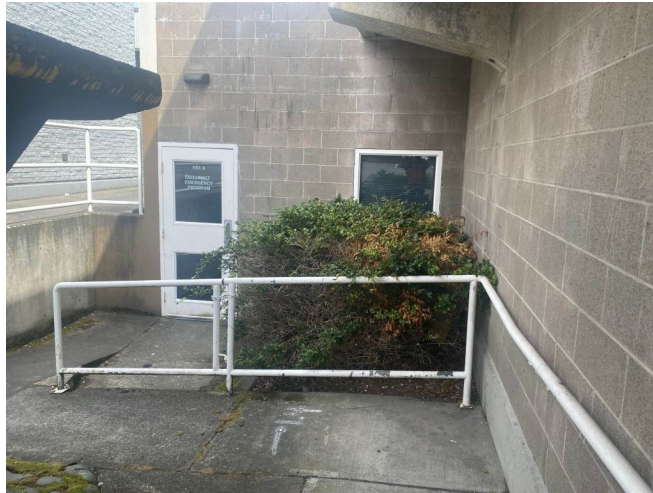
Photo #10: CMU Walls- Unpainted

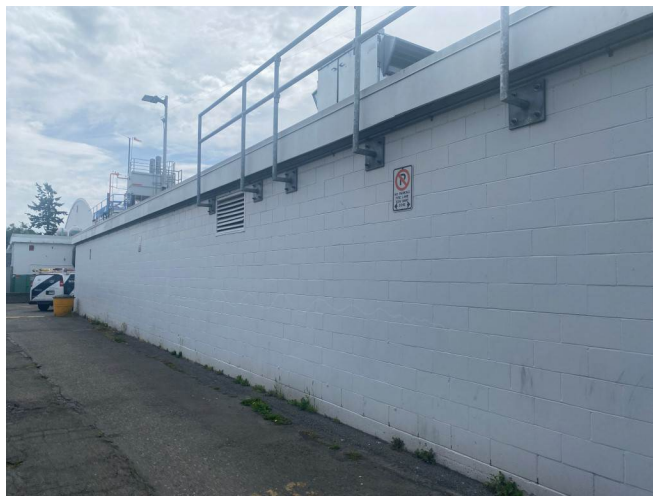
Photo #11: CMU Walls, Painted

CMU walls are in good condition; only repainting is planned for maintenance.

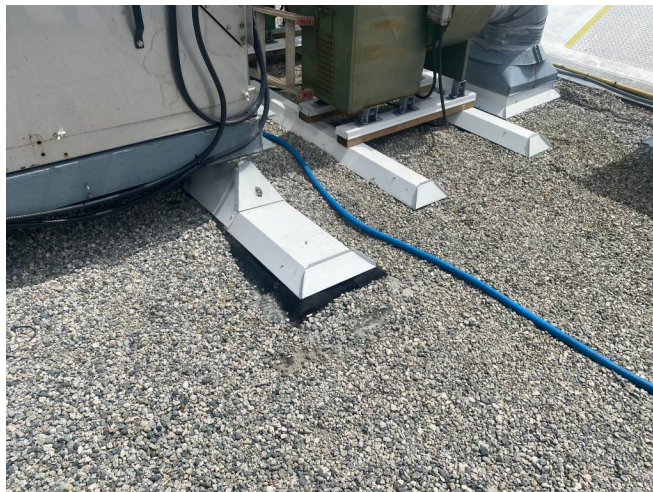
Photo #15: 2-Ply SBS Roofing with Gravel Balast

Flat roofs are scheduled for phased replacement: the oldest sections around the Hockey Arena office areas in the short term due to end-of-life condition, the eastern sections in the medium term, and the newer western and central areas near year 2045.

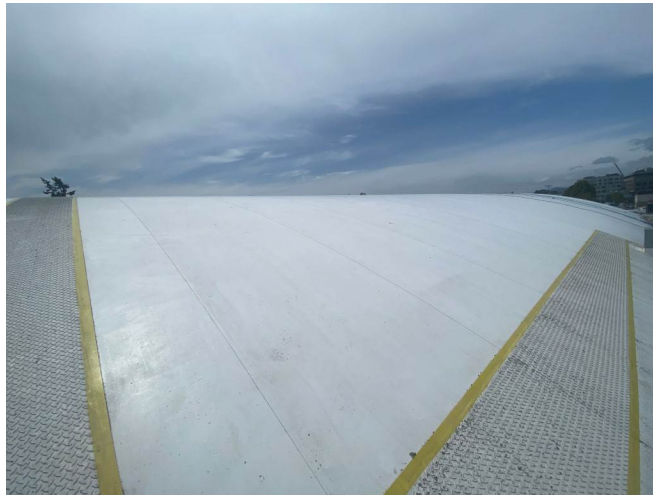
Photo #16: TPO Roofing

The main barrel roofs were replaced in 2007 with TPO membrane and are in serviceable condition. With continued annual maintenance,

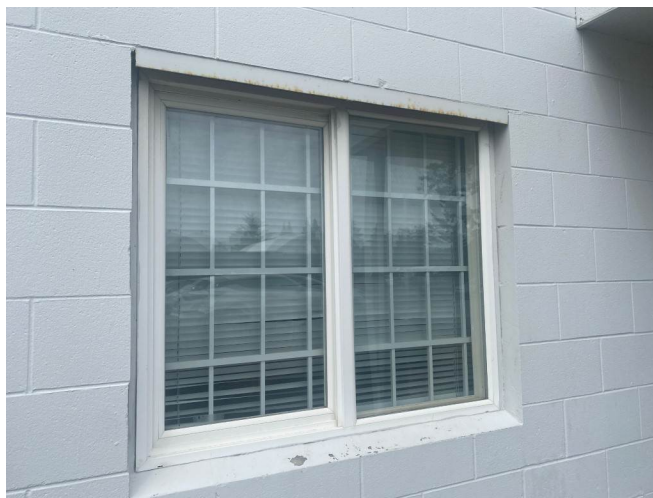
Photo #17: Newer Windows

Windows vary in age and performance. Older metal units are inefficient and prone to leakage. Newer units perform better but lack consistency. Full window replacement with uniform, thermally broken frames and IGUs is recommended.

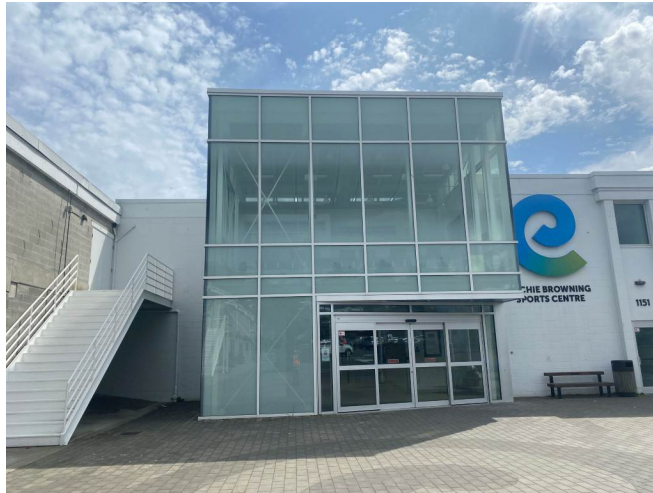
Photo #19: Main Entrance Curtain Wall System

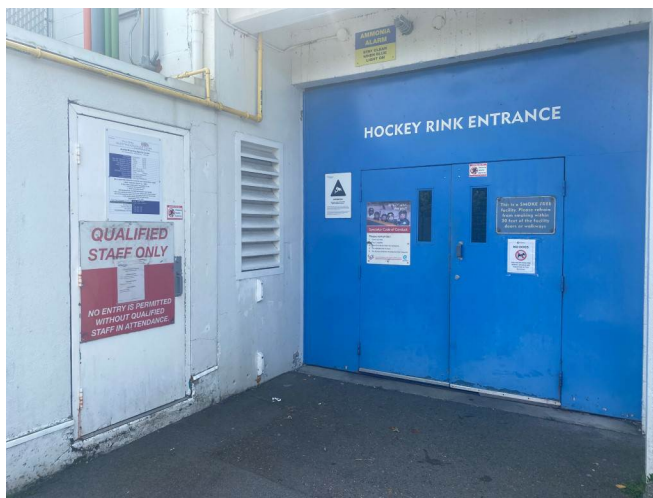
Photo #24: Service Doors, typical

Some metal service doors show corrosion and wear; about half are recommended for replacement this term.

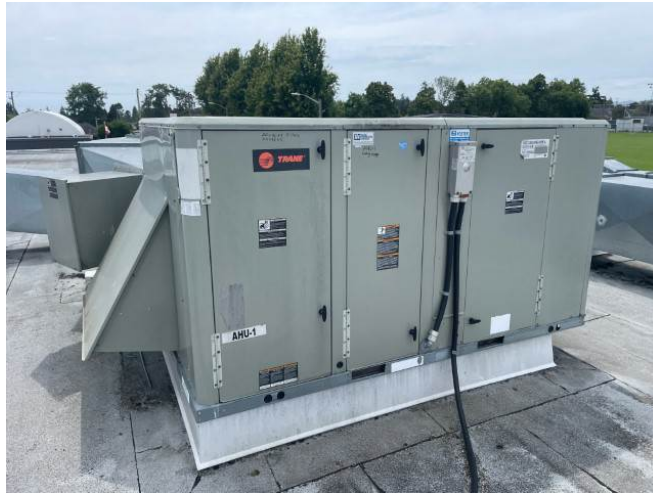
Photo #29: Packaged Rooftop Air Handling Unit - Typical

The air handling units are currently between 10 to 14 years old. Based on the age of the equipment, escalating repair needs should be expected, with costs likely to be affected by the phase-out of R-410A refrigerant. Based on a typical service life, general replacement of all units is anticipated within the next 10 to 15 years.

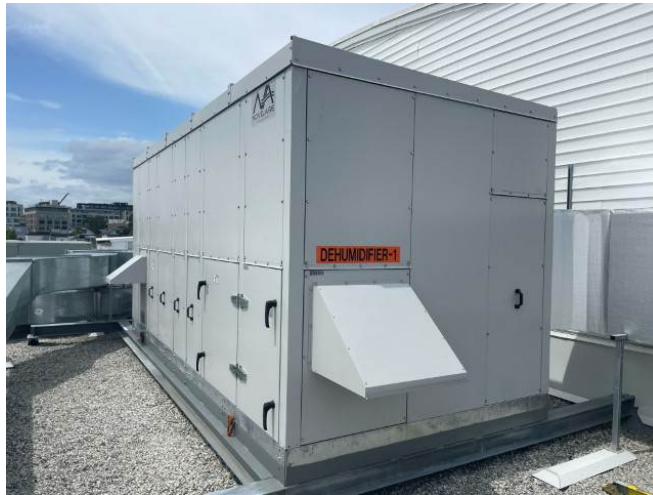
Photo #32: New Hockey Rink Dehumidifer Unit

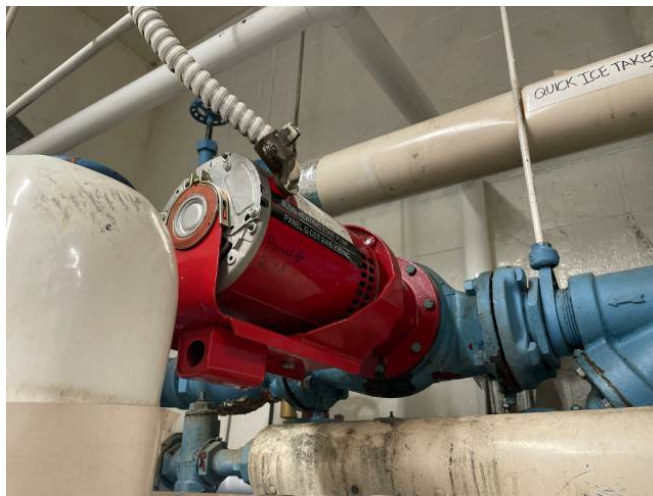
Photo #39: Hydronic Heating Circulation Pump - Typical
