Project No. CA0053161.3566

**BUILDING CONDITION ASSESSMENT**  
**ESQUIMALT RECREATION CENTRE**  
**527 FRASER STREET**  
**Victoria, British Columbia**

DECEMBER 16, 2025

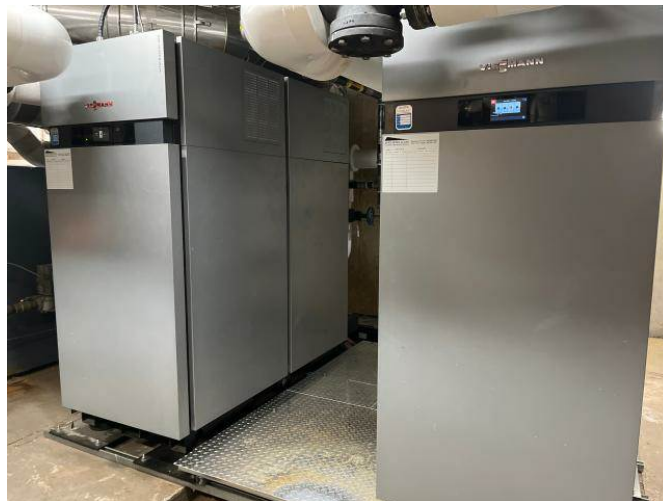
Photo #15: Central Heating Plant - Two New Boilers

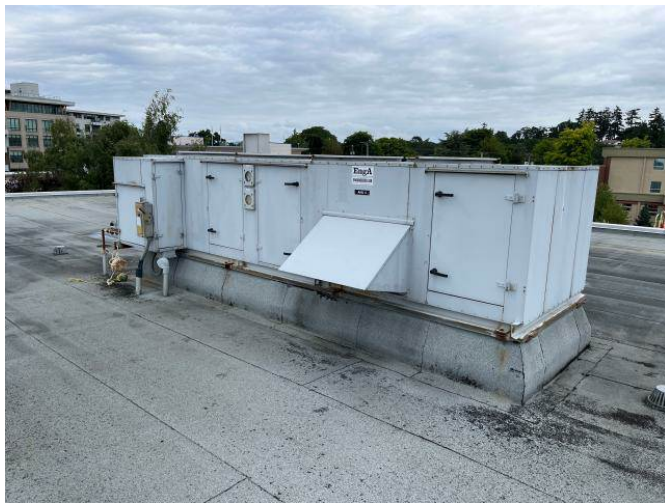
Photo #17: Roof-Top Air Handling Unit

The pool air handling unit/dehumidification unit (AHU1) is in poor condition and requires replacement in the near future along with the heat recovery ventilator on top of the unit. The other three outdoor air handling units (AHU4, AHU5 and AHU6) are also expected to

require replacement in the next five years. The two indoor air handling units (AHU2 and AHU3) are old but functional, with some component replacement expected over the next five years.

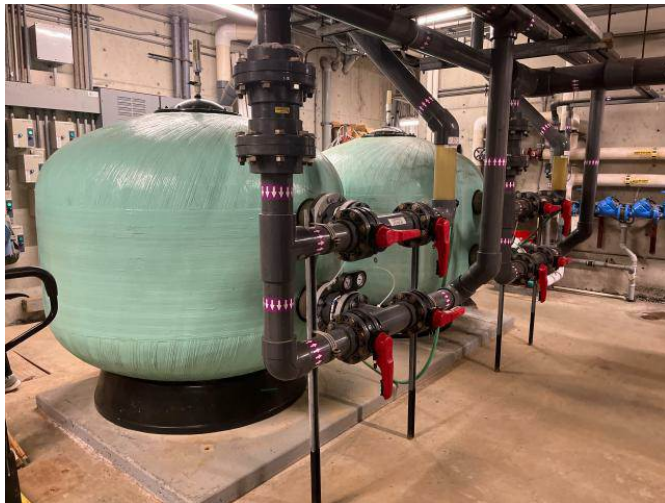
Photo #24: Pool Filter - Typical

Pool specialty mechanical systems such as filters, pumps, controls and monitors will all require extensive ongoing maintenance and repairs, as well as replacement of components as these systems age. Preliminary budgets for replacing the larger components have been included, generally scheduled to aligning with your existing capital plan.
