**KERR WOOD LEIDAL**  
consulting engineers

# Inflow and Infiltration Masterplan

Final Report  
August 24, 2021  
KWL Project No. 0601.010

Prepared for:  
Township of Esquimalt

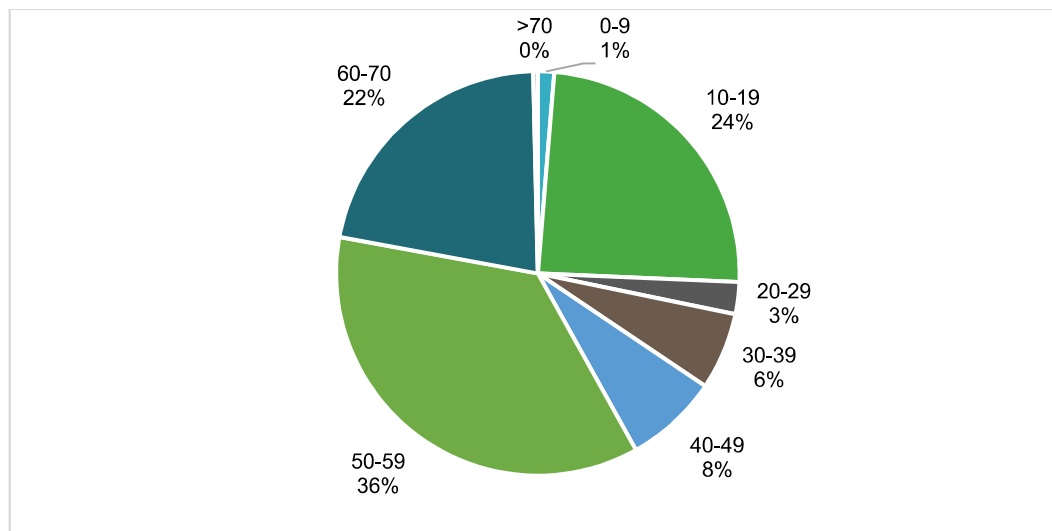
**Figure 3-2: Breakdown of Length of Pipe by Age**

The average age of pipe in the Township is 44.9 years old. Pipes older than 50 years have been found to have higher than average I&I rates and 58% of the Townships sewers are older than 50 years old. 66% of sewers are older than 40 years old. Therefore, the majority of the Township's sewers are

expected to have higher than typical I&I based on age alone. Figure 3-2 below shows the breakdown of pipe age across the Township.

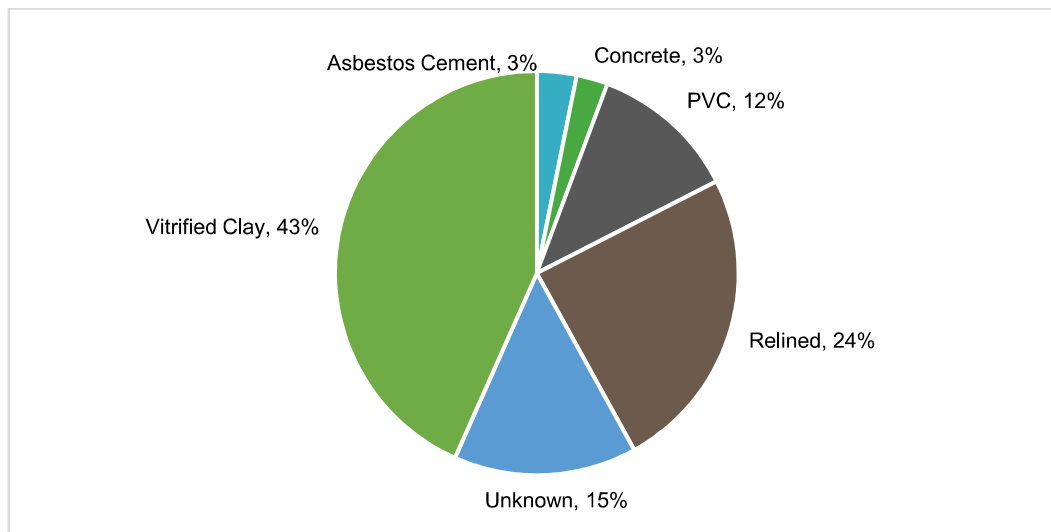
**Figure 3-3: Breakdown of Pipe Length by Material**

Figure 3-3 below shows the breakdown of pipe material across the Township. Vitrified clay pipes make up 43% of the total pipes within Esquimalt. Note that in 2009 the Township completed a significant lining project, lining 24% of the system.

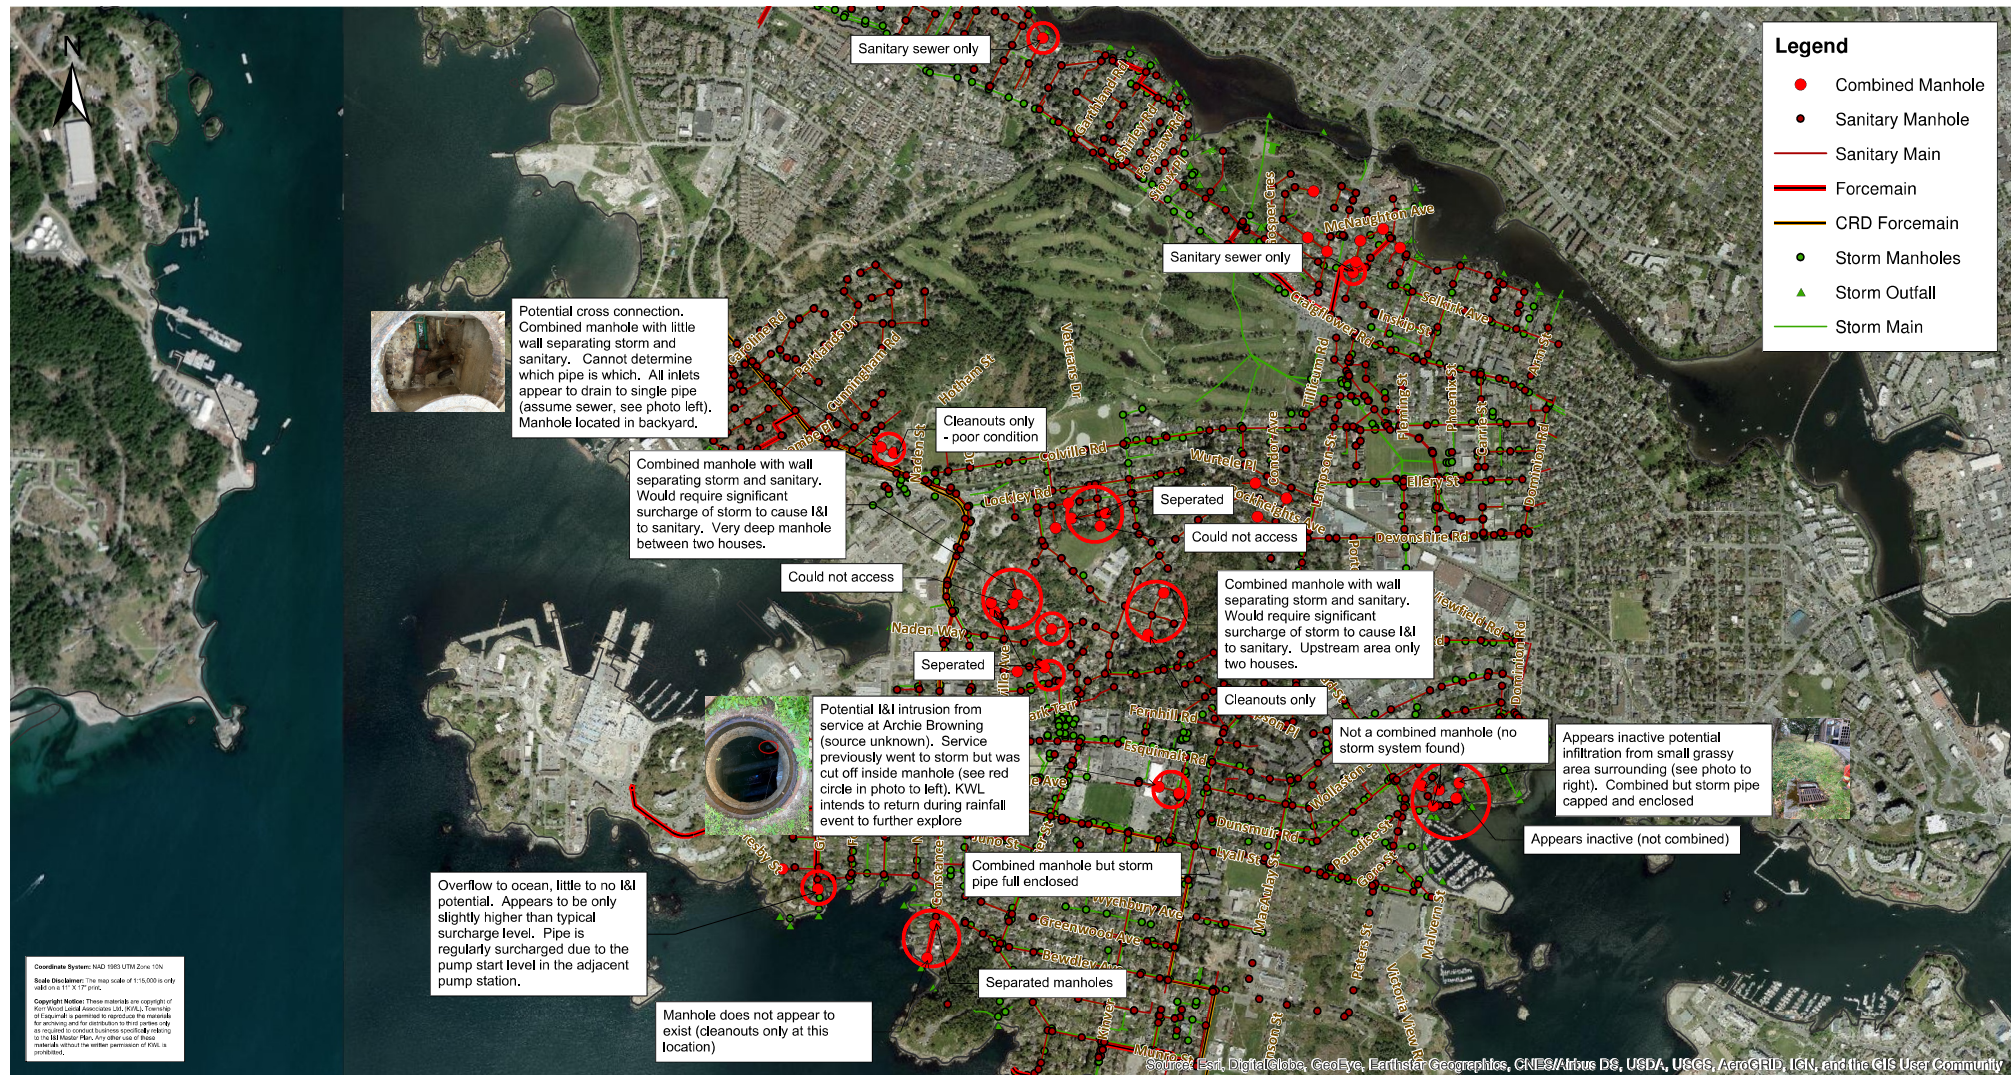
**Figure 5-1**

The combined manholes remaining are typically those that are most difficult to separate or are located at the top end of the system leaving very little I&I potential. The locations and findings of the combined manhole inspection are included in Figure 5-1 below.

A direct storm to sewer connection was located in combined manhole SMH0686 at the Archie Browning Sport Centre outside the east entrance. The service appears to have previously been piped across the sewer main and into the storm main but appears to have been cut off inside the manhole, no flow was noted during the inspection however KWL returned to the site during a light rainfall event and noted that the pipe was flowing. The origin of the service connection is unknown but could represent a significant source of I&I if connected directly to roof or parking lot drains.

SMH0305 is a combined manhole at end of system with a wall separating storm and sewer benching. Significant surcharging in system would be required to cause a cross-connections.

We recommend that the Township determine where the active services are located for 847 Dunsmuir Road and 531 West Bay Terrace and disconnect, cap, and abandon all non-active sewers as they are a likely source of I&I.

The direct connection noted above and found through our field investigation should be redirected where possible and the sewers at 847 Dunsmuir Road should be investigated to determine if they can be abandoned.

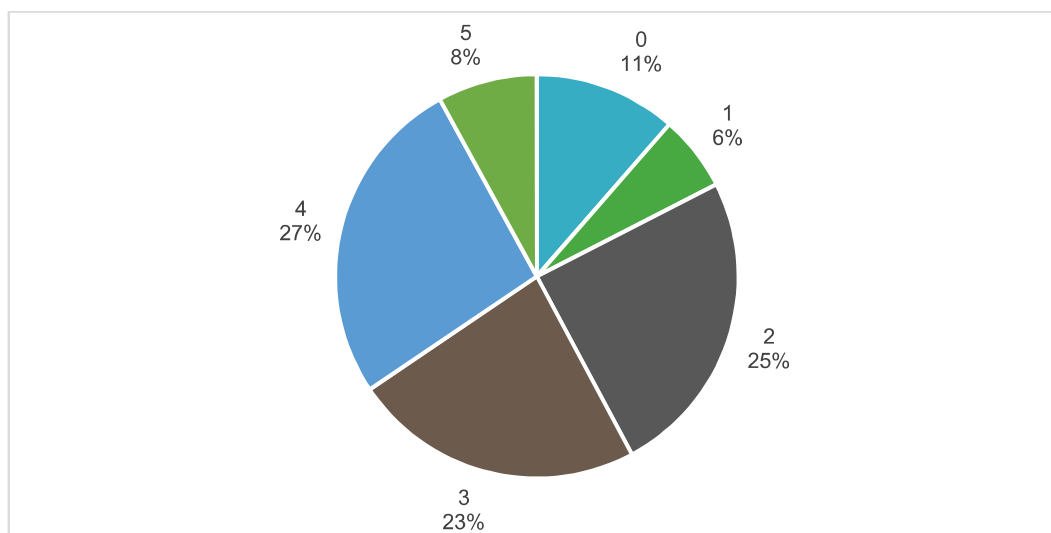
**Figure 6-2: Breakdown of Inspected Pipe Length by CCTV Peak Score**

The 20 km of CCTV provided was broken up into several databases, KWL combined the data into a single database and removed duplicate or updated inspection data. The most recent complete pipe inspection was used. Any pipes with greater than 80% of the length inspected was assumed to be a completed inspection. The following figure shows the breakdown of inspection results of videoed pipes based on the peak structural defect score.

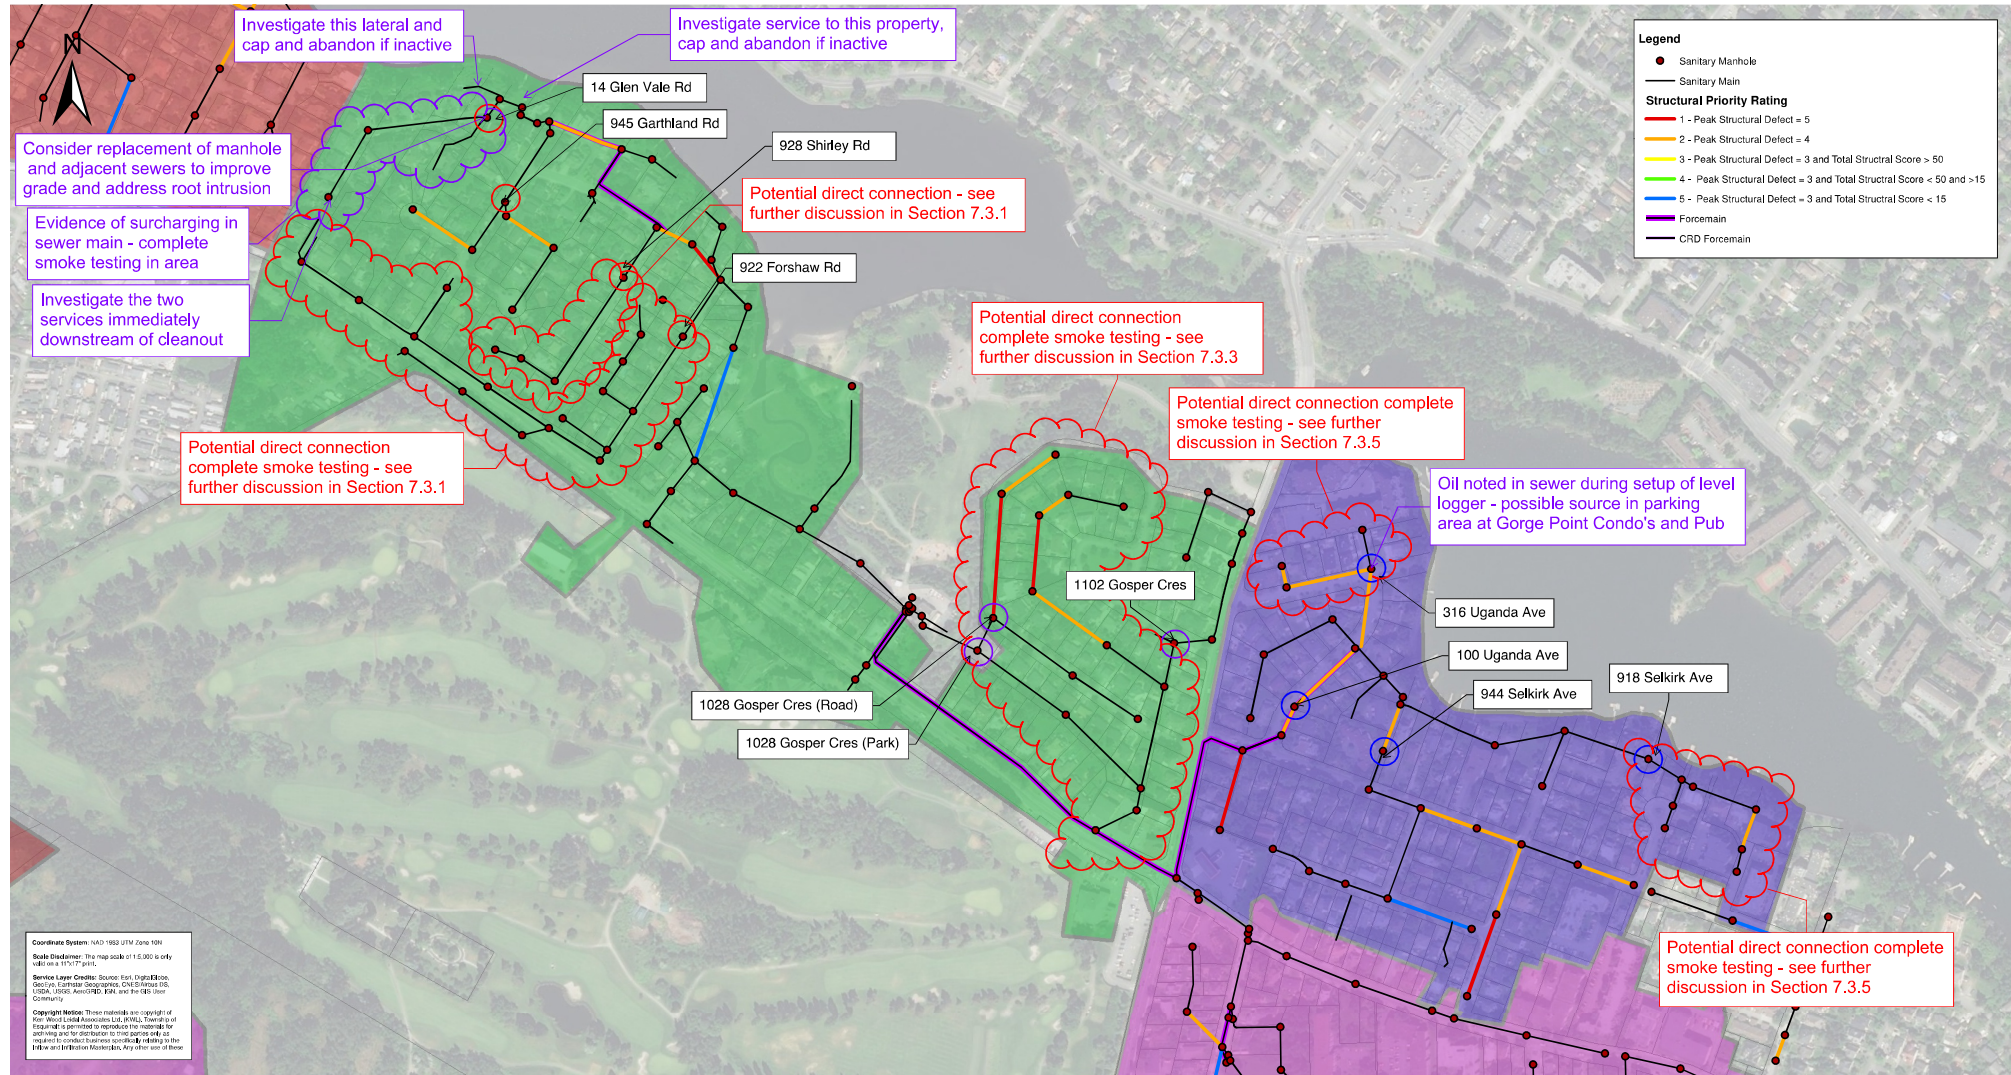
**Figure 7-6**

The monitoring locations within the Upper Forshaw Area are shown in red on Figure 7-6 above. This area encompasses the streets feeding into the Glen Vale Pump Station and the trunk main at Sioux Place. This area encompasses primarily residential land use with adjacent park land.

The monitoring locations within the Gosper Crescent Area are shown in purple on Figure 7-6 above. This area encompasses the Gosper Crescent neighbourhood area west of Tillicum Road up to the pump station at 1100 Craigflower Road. This area encompasses primarily residential land use with adjacent park land.

The monitoring locations within the Uganda Catchment are shown in blue on Figure 7-6 above. This area encompasses the area border to the east by Tillicum Road, the Gorge to the north, Craigflower Road to the south, and Dingley Dell to the west. The catchment drains to the Uganda pump station which discharge upstream of the gravity trunk through the Devonshire Catchment. This area encompasses primarily residential land use with adjacent park land.

The following list of action items in the Upper Forshaw Area are recommended based on the results of the level monitoring analysis. Locations can also be found on Figure 7-6 above.

The following list of action items in the Gosper Crescent Area are recommended based on the results of the level monitoring analysis. Locations can also be found on Figure 7-6 above.

The following list of action items in the Uganda Catchment are recommended based on the results of the level monitoring analysis. Locations can also be found on Figure 7-6 above.

1. Colville Street: Ensure that inspectors look for smoke at the base hospital, at properties noted on Figure 7-4, and golf course lands as well as all other areas serviced by the sewer.
2. Uganda areas (as identified on Figure 7-6): Ensure inspectors investigate at the Gorge Point Condos and Gorge Point Pub as there are suspected cross connected CB's at this location. Ensure inspectors investigate the frontages of the waterfront properties. Smoke testing in this area could be affected by the nearby Uganda Pump Station and isolation from any overflows and combined manholes in the area would be required.
3. Forshaw areas (as identified on Figure 7-6): Ensure to investigate locations noted on Glen Vale Road. Investigate the service at 940 Garthland that is tied into the sewer between SMH0092 and SMH0093.
